the **play inspection** company

Annual Inspection

Winchester City Council

Olivers Battery Recreation Ground

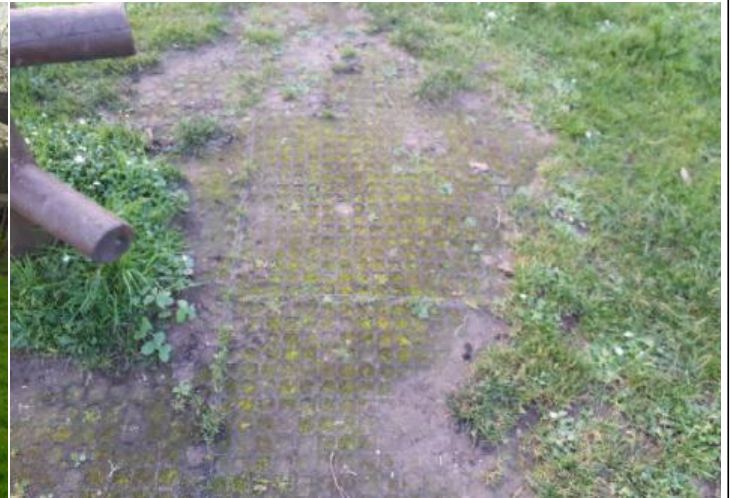
Finding: There is algae, silt or moss growth on the surface resulting in slippery conditions
Action: Clean and treat appropriately

There is algae, silt or moss growth on the surface resulting in slippery conditions - Clean and treat appropriately

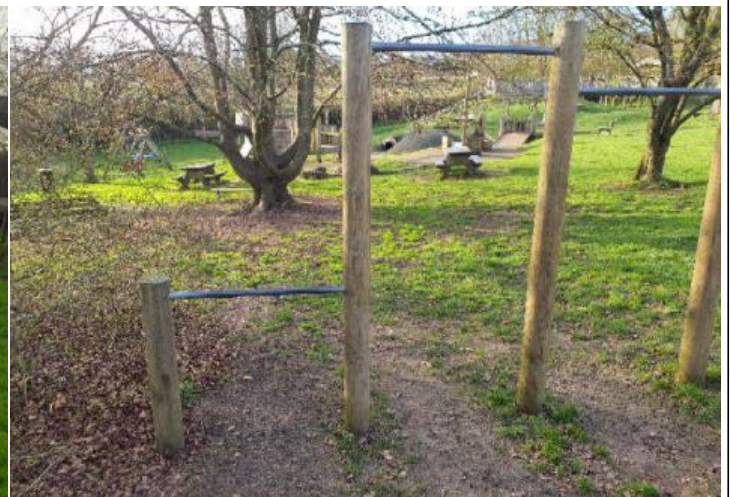
Finding: It is recommended that Adult Outdoor Fitness equipment is installed a minimum of 25m away from a childrens playground or separated and screened to discourage access by younger children
Action: Monitor use and review risk assessment regularly

It is recommended that Adult Outdoor Fitness equipment is installed a minimum of 25m away from a childrens playground or separated and screened to discourage access by younger children - Monitor use and review risk assessment regularly

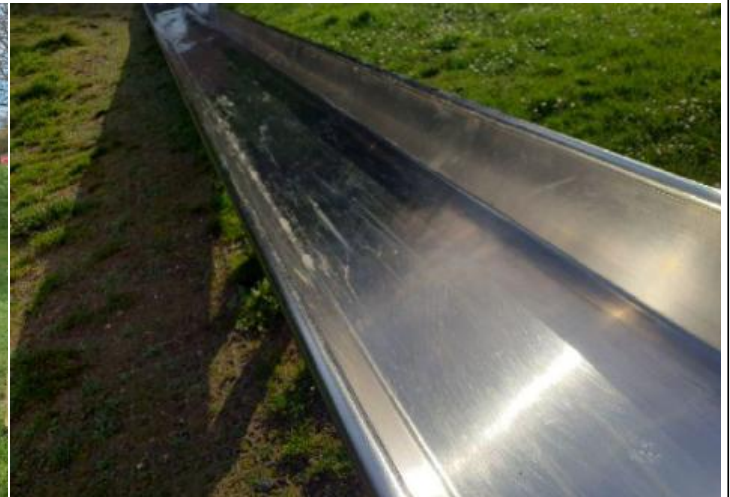
Finding: There are a number of dents in the slide surface **Action:** Monitor for any further deterioration and repair as required

There are a number of dents in the slide surface - Monitor for any further deterioration and repair as required

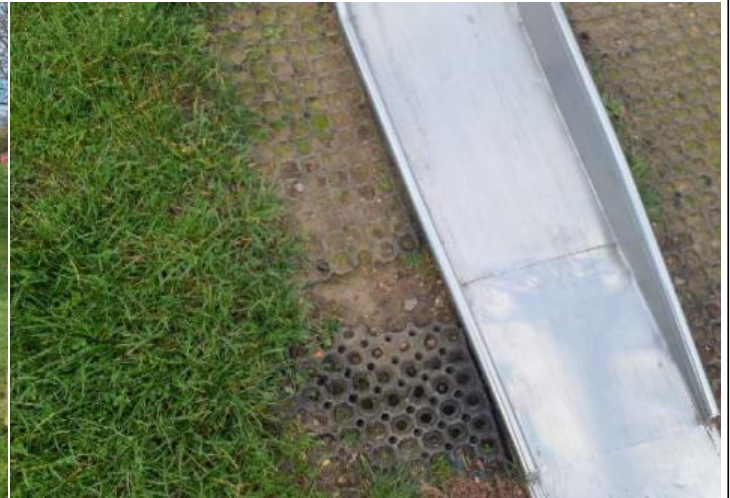
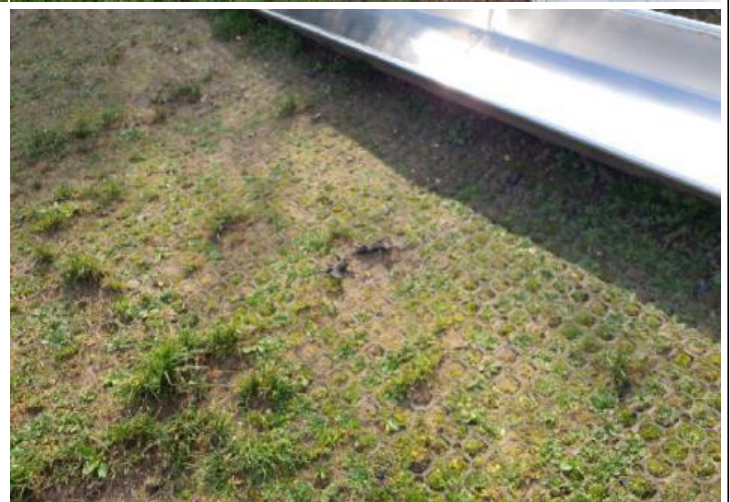
Finding: There is moderate damage to the surface

Action: Repair the damaged areas of surfacing

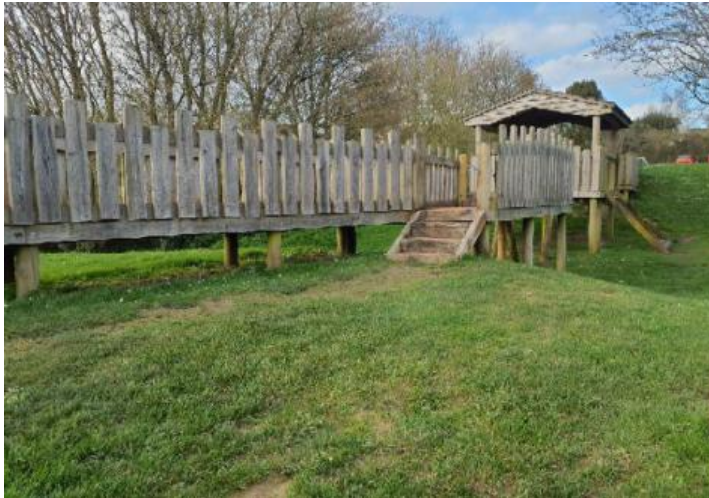
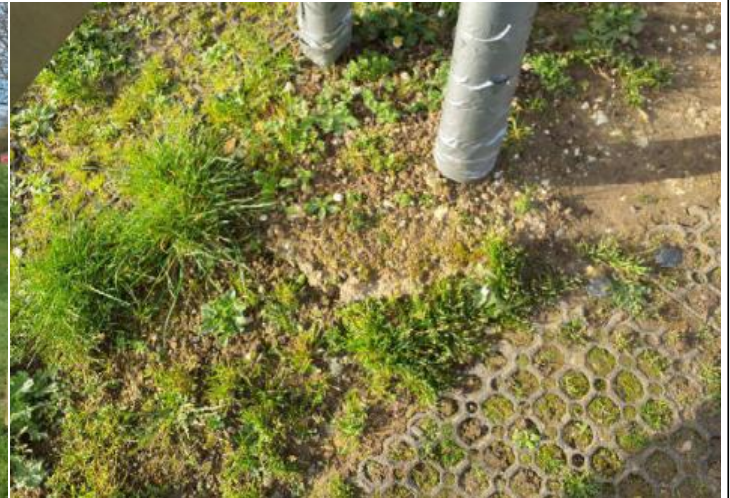
Finding: The surface has eroded and the foundations are exposed

Action: Reinstate surrounding surfaces to cover the foundations

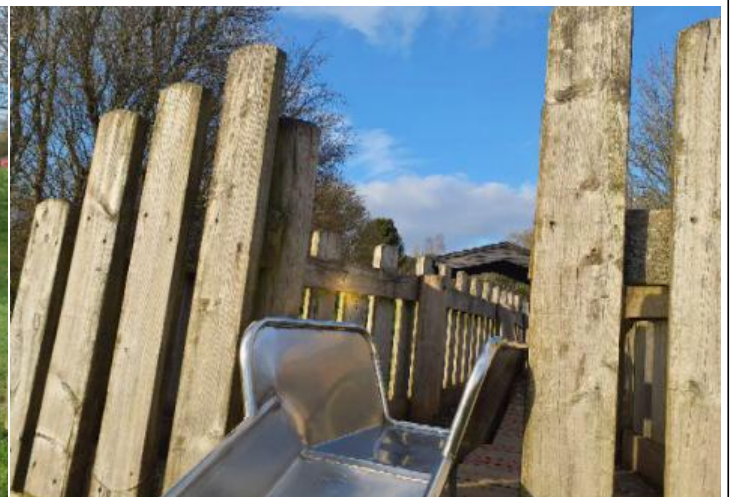
Finding: This item has no slide bar fitted as required by BS EN 1176 Part 3

Action: Monitor - No remedial work recommended

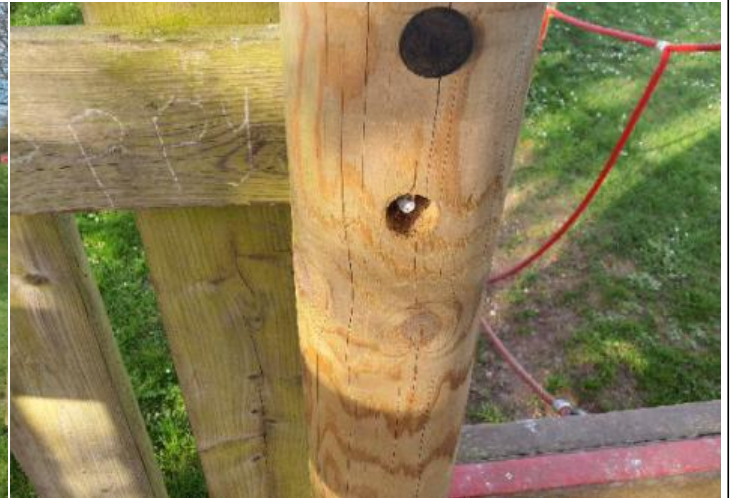
Finding: There is/are bolt cap covers missing or damaged on the item

Action: Replace missing or damaged bolt cap covers

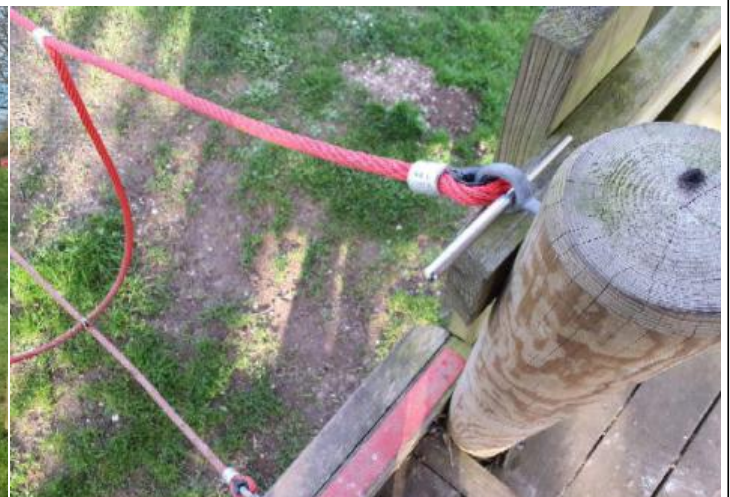
Finding: The connecting links are in excess of 8.6mm and less than 12mm and fail the requirements of BS EN 1176 Part 1; clause 4.2.13, Chains

Action: Monitor - No remedial work recommended

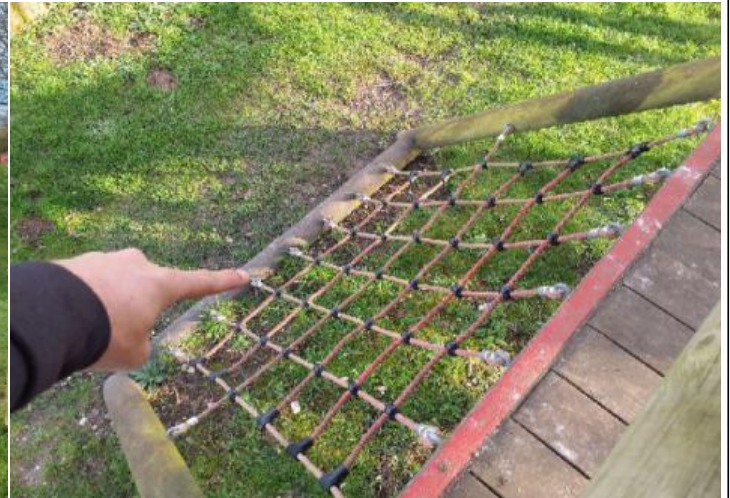
Finding: There are falls in excess of 600mm between adjacent components on the structure, in contravention of the recommendations set out in BS EN 1176 Part 1; 4.2.8.4

Action: Monitor - No remedial work recommended

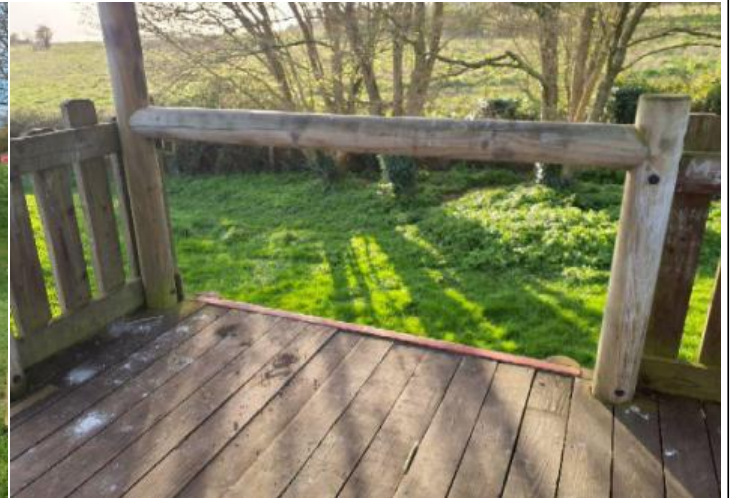
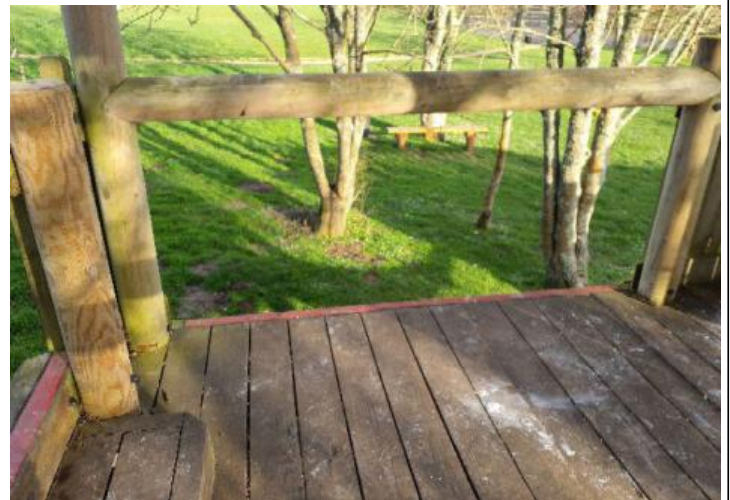
Finding: There is an opening in the barriers exceeding the width allowed (500mm) in BS EN 1176, this is a low risk failure and no remedial action is required

Action: Monitor - No remedial work recommended

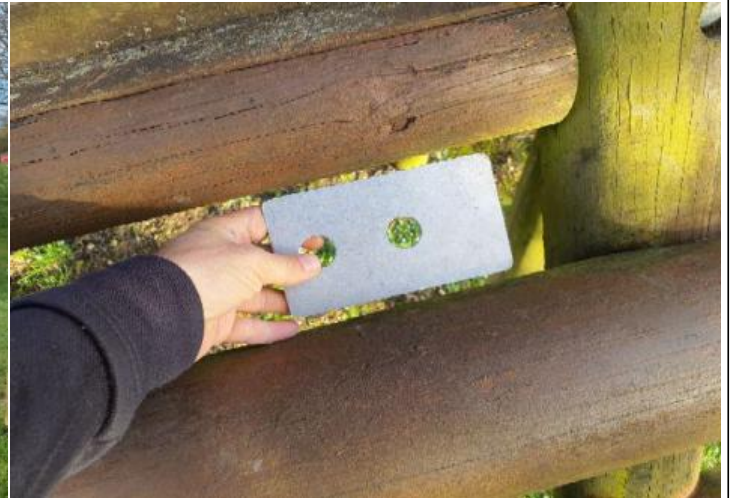
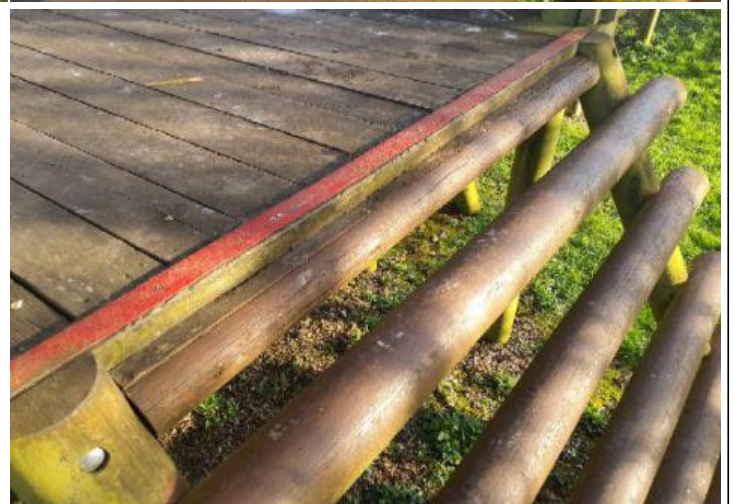
Finding: The item fails to meet the requirements of BS EN 1176 Part 1 4.2.7.2 for head and neck entrapment in the structure

Action: Monitor - No remedial work recommended

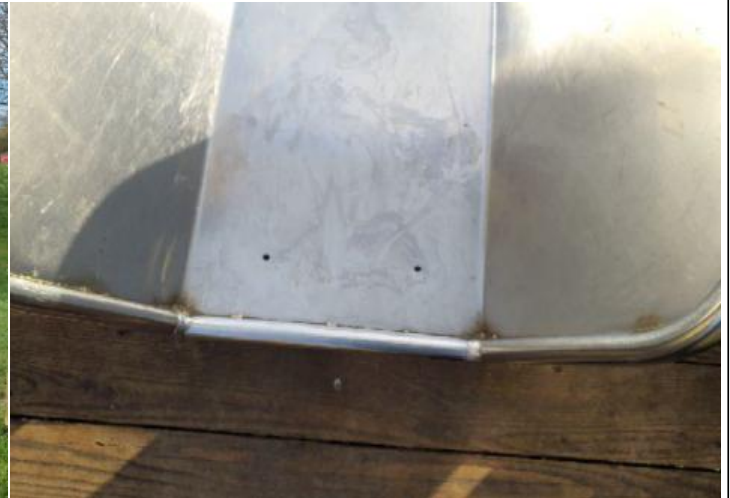
Finding: There is/are inserts missing

Action: Replace missing inserts

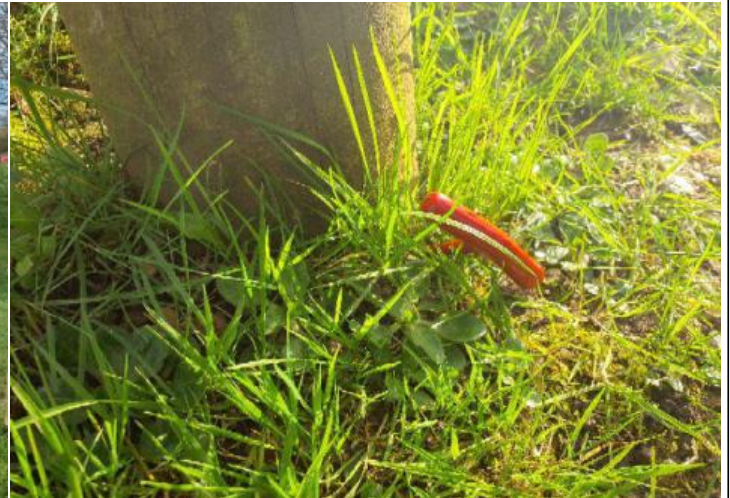
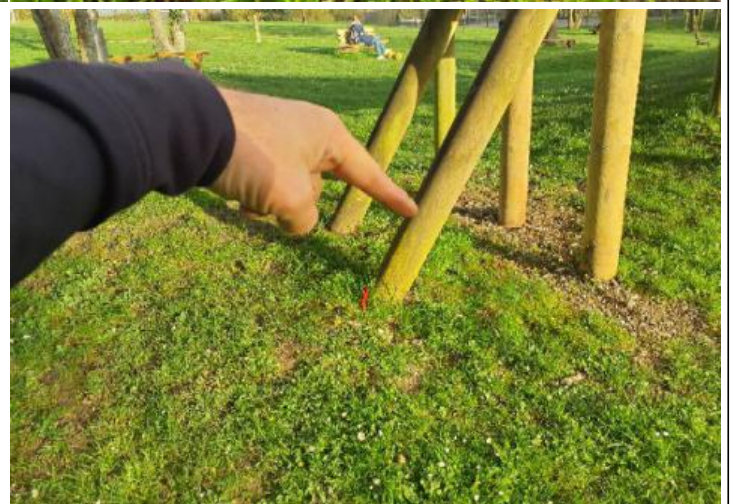
Finding: There are areas or parts of the timber on the structure that have rotted

Action: Replace all affected timbers

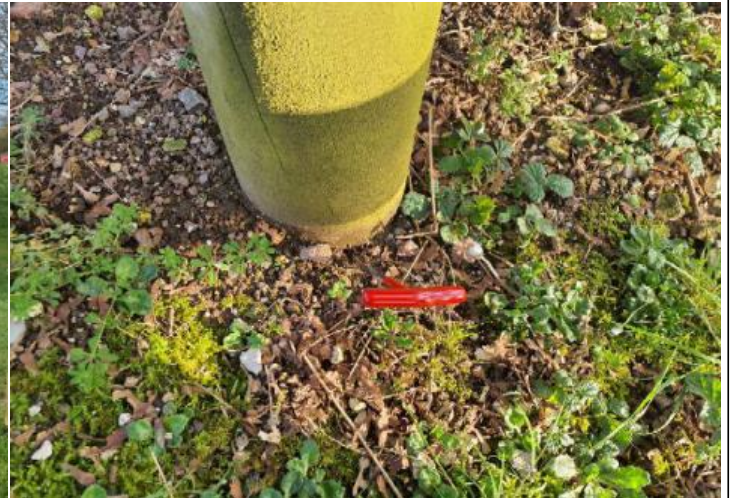
Finding: There is some evidence of rot in the timber

Action: Monitor for any further deterioration and replace as required

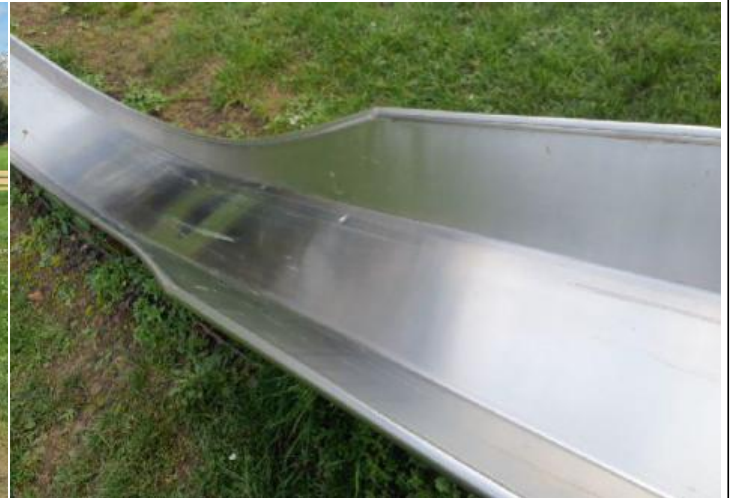
Finding: There are a number of dents in the slide surface

Action: Monitor for any further deterioration and repair as required

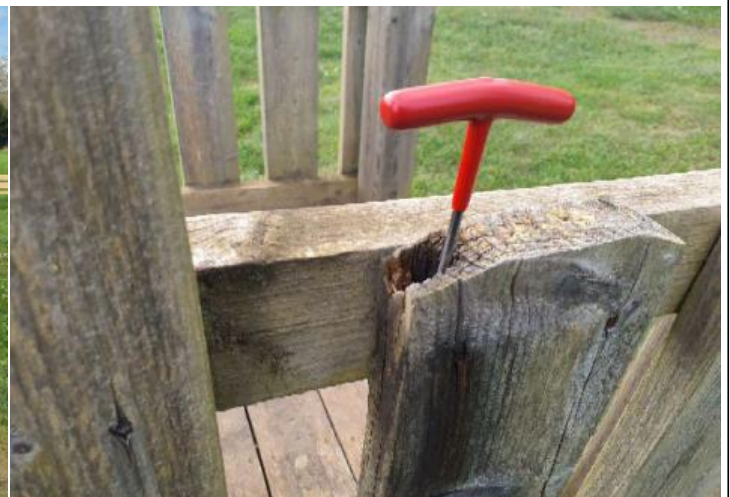
Finding: There is some evidence of rot in the timber

Action: Monitor for any further deterioration and replace as required

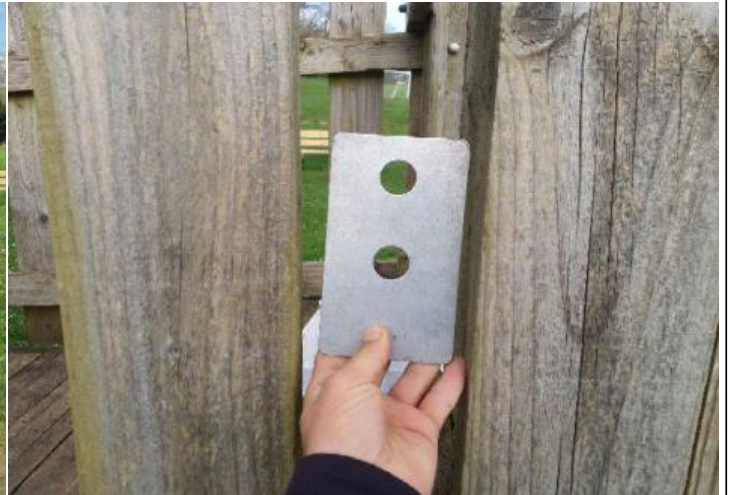
Finding: The item fails to meet the requirements of BS EN 1176 Part 1 4.2.7.2 head and neck entrapment in the barriers and/or steps

Action: Monitor - No remedial work recommended

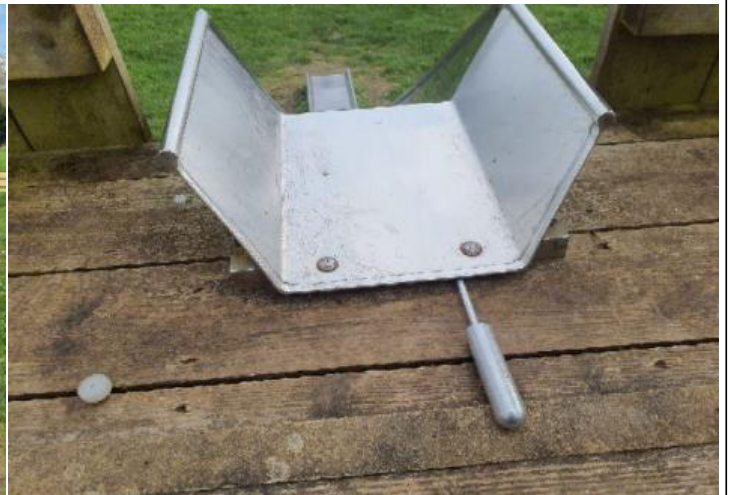
Finding: There is/are finger entrapment/s in the slide starting section and the item fails to meet the requirements of BS EN 1176 Part 1 4.2.7.6 Entrapment of fingers

Action: Monitor - No remedial work recommended

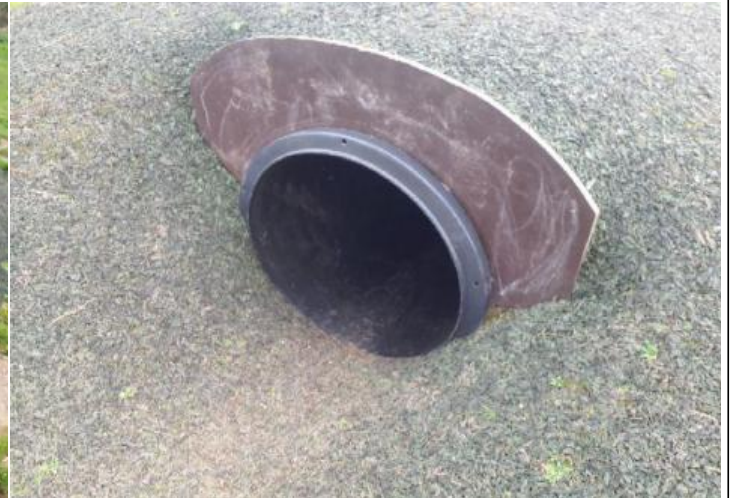
Finding: This design / configuration of tunnel mound is well established and has been successfully included in large quantities of playgrounds throughout the UK. Whilst the design does not fully meet the requirements of BS EN 1176 with regards to falls in excess of 600mm over the edge of the tunnel to the surface below, it has been risk assessed as fit for purpose in this regard and no changes are recommended to the design unless otherwise stated in additional findings

Action: Monitor - No remedial work recommended

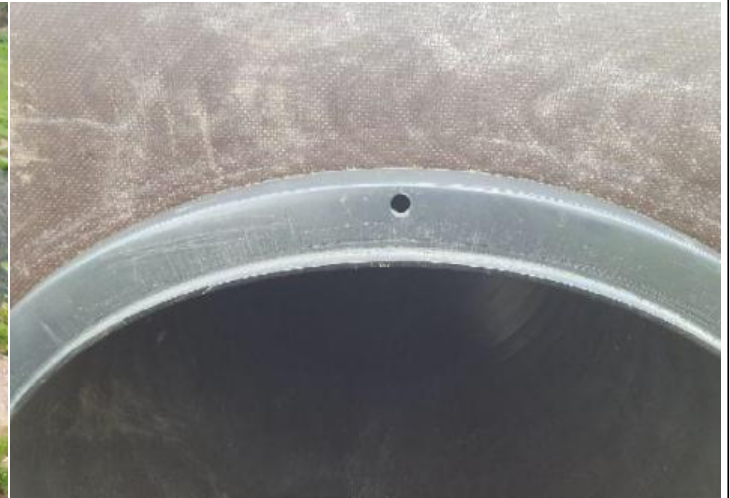
Finding: There is/are inserts missing

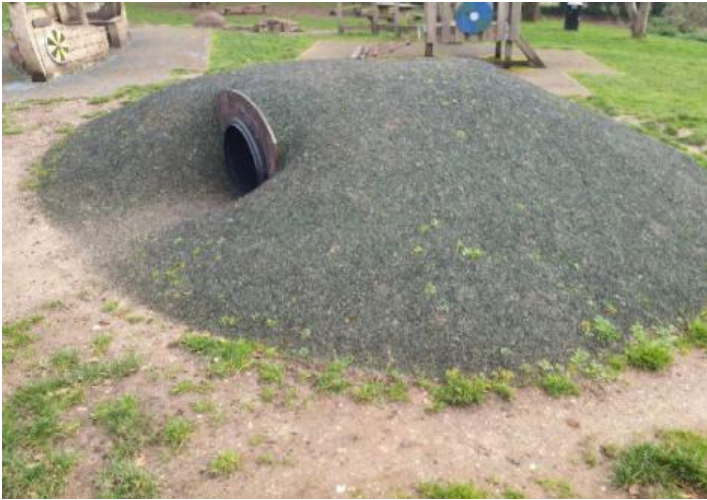
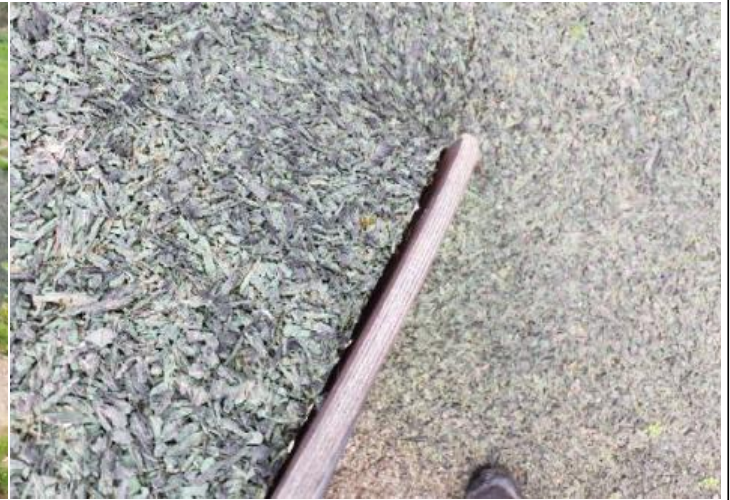
Finding: There are gaps opening between the surfacing and the edging surround or between the joints in the surfacing
Action: Monitor for any further deterioration and repair as required

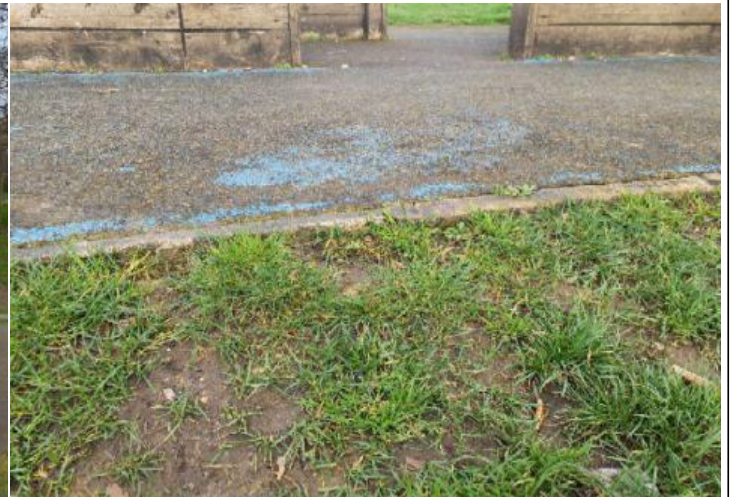
Finding: There are trip hazards at the edges of the surface
Action: Reinstate surrounding surface levels to remove the trip points

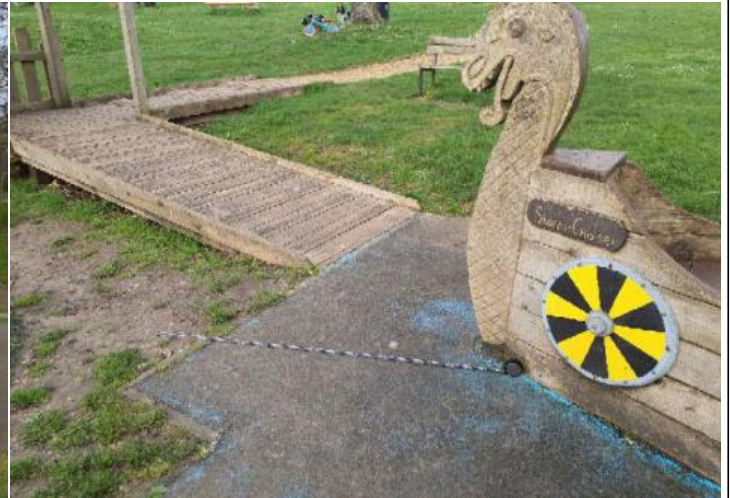
Finding: The surfacing dimensions are short and do not meet with the requirements of the current applicable standard

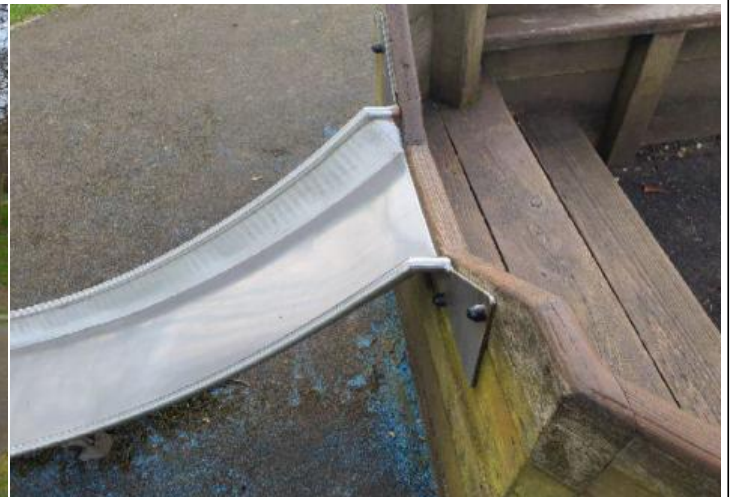
Finding: The slide start section is less than 350mm long and fails the requirements of BS EN 1176 Part 3

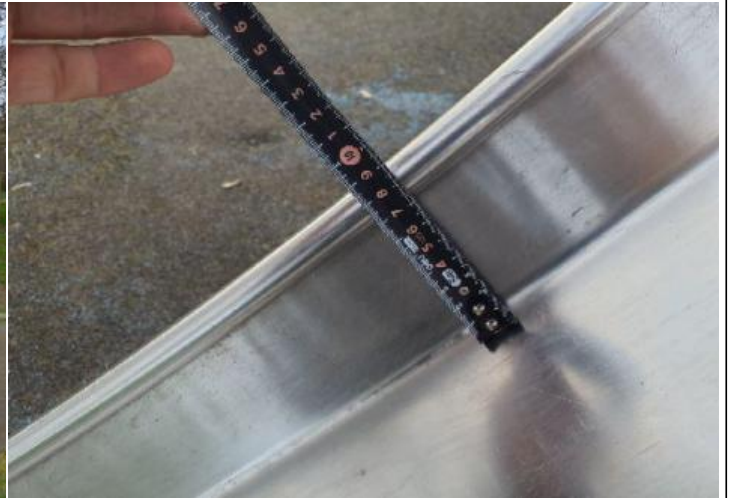
Finding: The lateral slide protection is less than 100mm in height and fail the requirements of BS EN 1176 Part 3

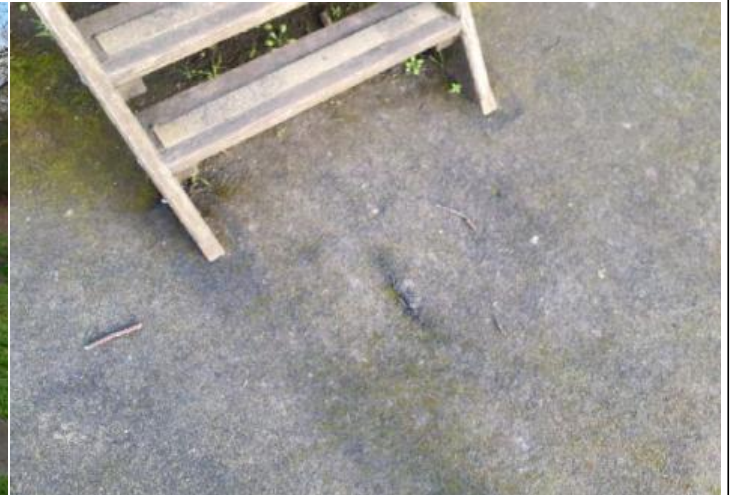
Finding: There is some minor damage to the surface

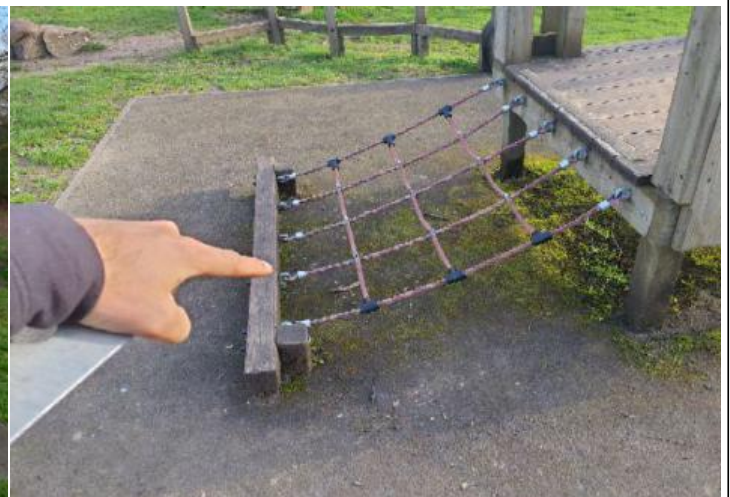
Finding: The beam forms a projecting obstacle / hard object within the falling space of the equipment, in contravention of the requirements of BS EN 1176 Part 1

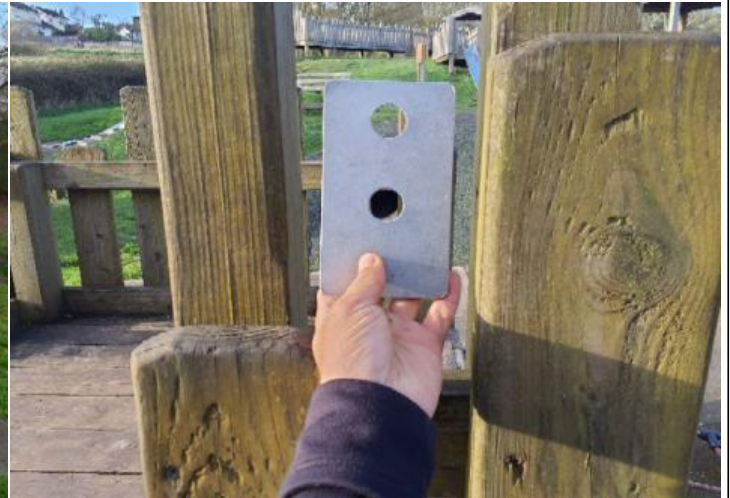
Finding: The item fails to meet the requirements of BS EN 1176 Part 1 4.2.7.2 head and neck entrapment in the barriers and/or steps

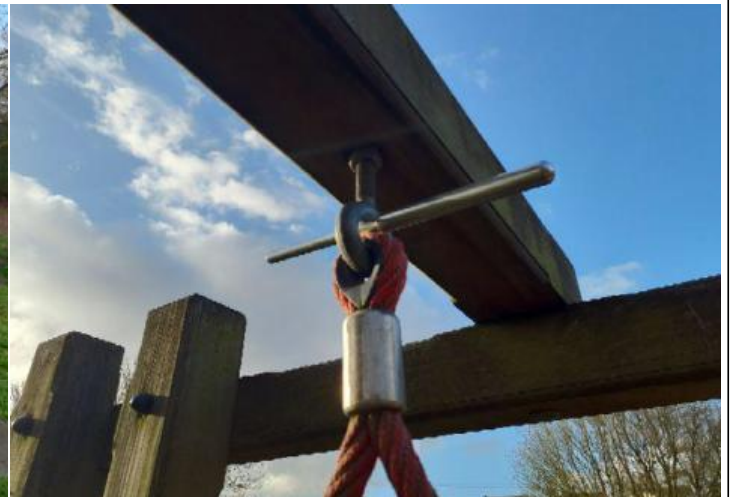
Finding: The connecting links are in excess of 8.6mm and less than 12mm and fail the requirements of BS EN 1176 Part 1; clause 4.2.13, Chains

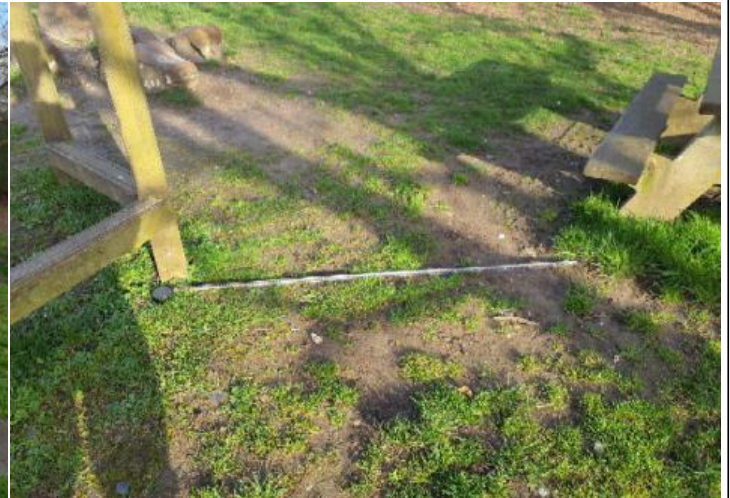
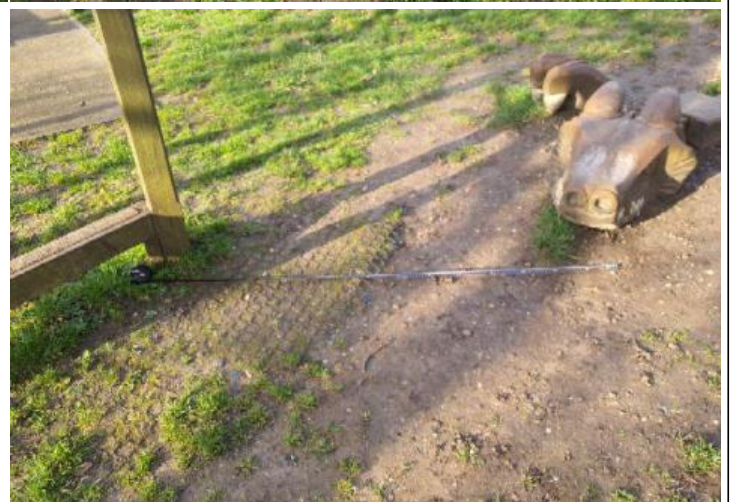
Finding: The picnic table / sculpture forms a projecting obstacle / hard object within the falling space of the equipment, in contravention of the requirements of BS EN 1176 Part 1

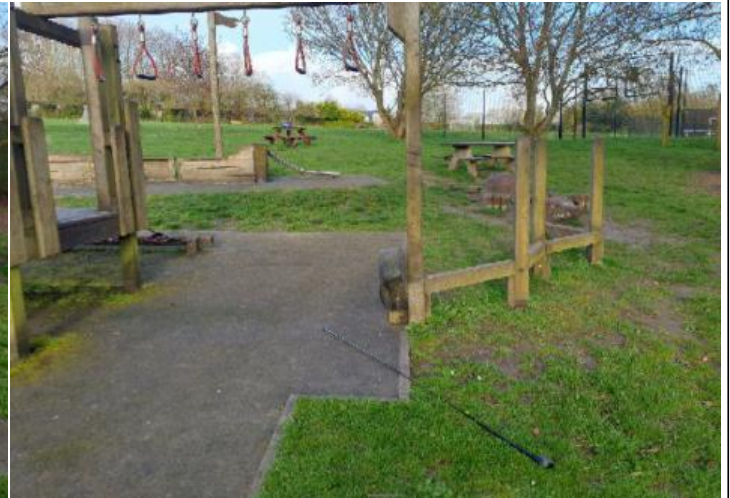
Finding: The surfacing dimensions are short and do not meet with the requirements of the current applicable standard

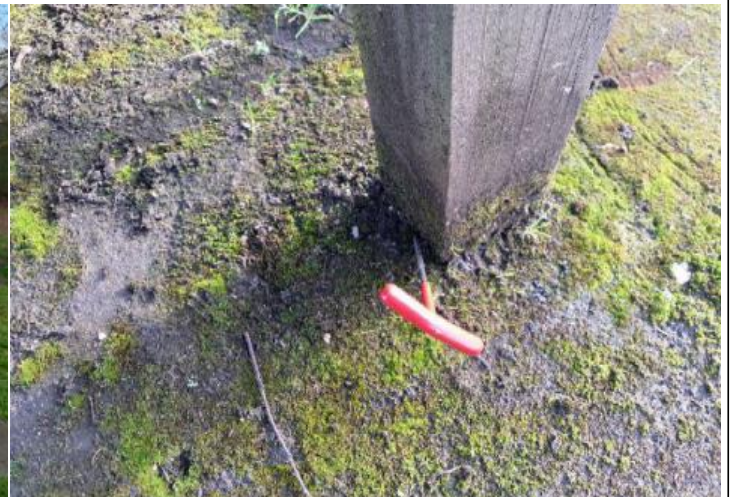
Finding: There is some evidence of rot in the timber

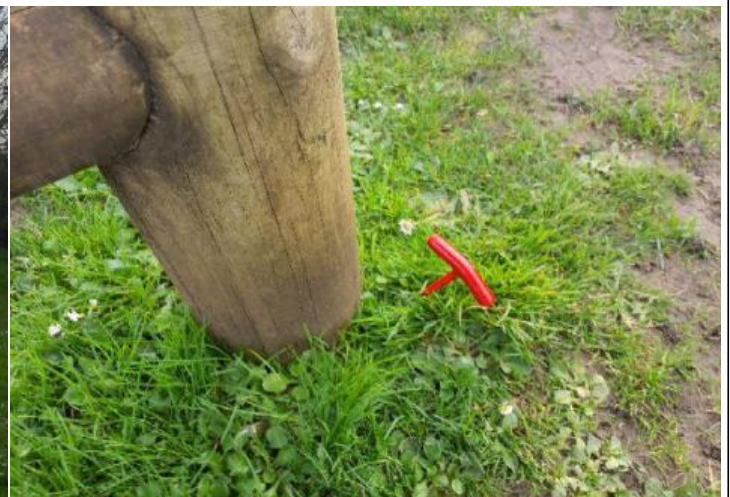
Finding: There is some evidence of rot in the timber **Action:** Monitor for any further deterioration and replace as required

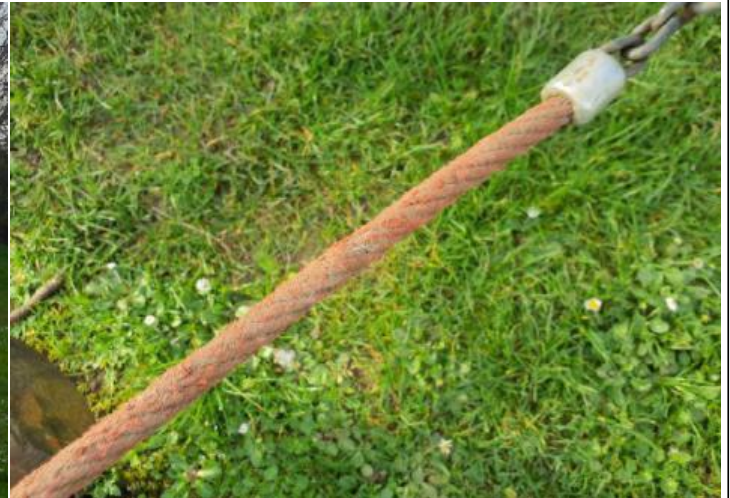
Finding: The ropes/nets are worn/damaged in places

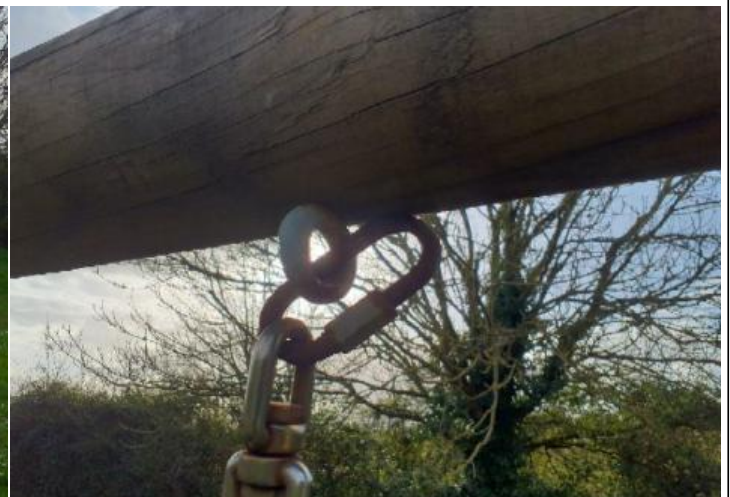
Finding: There is some notable evidence of connecting link wear

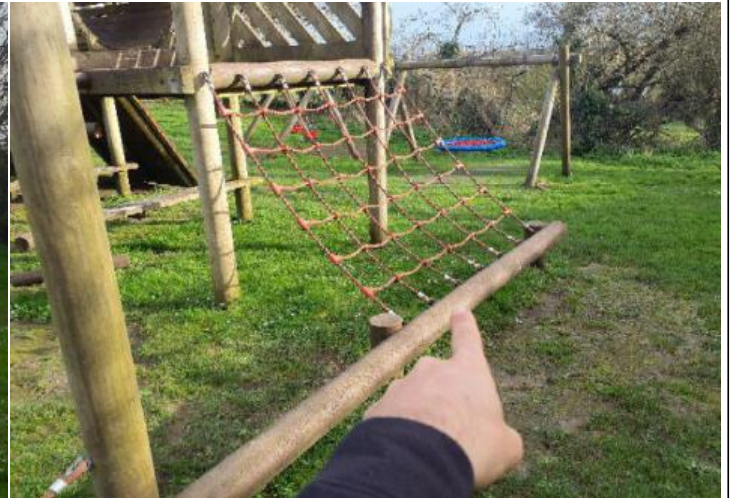
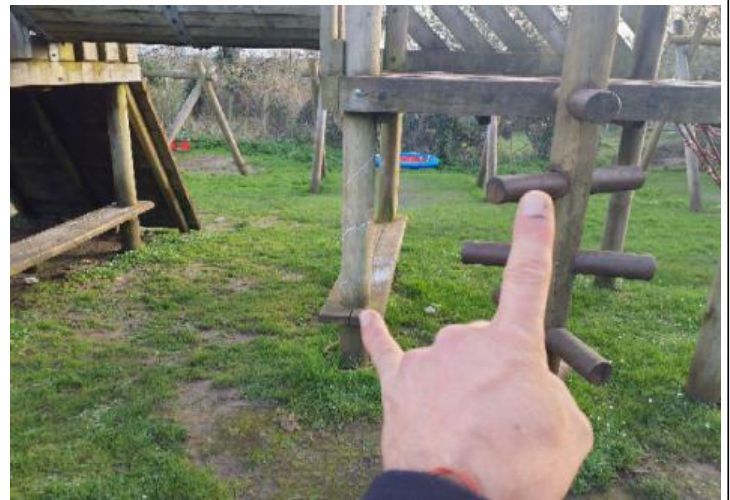
Finding: There are falls in excess of 600mm between adjacent components on the structure, in contravention of the recommendations set out in BS EN 1176 Part 1; 4.2.8.4

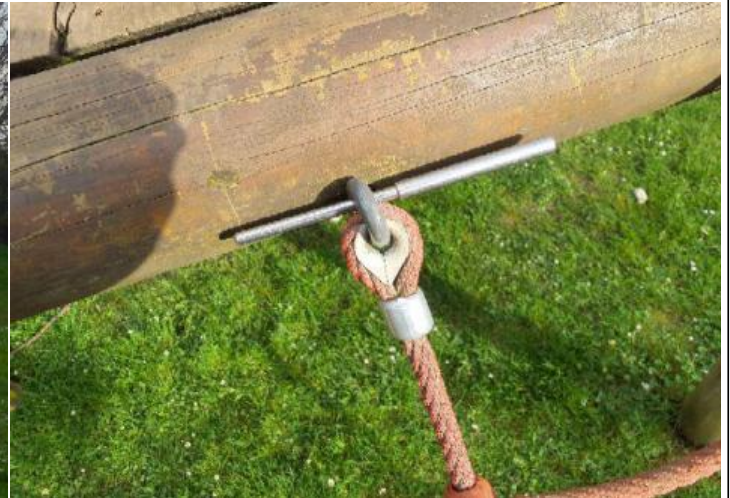
Finding: The connecting links are in excess of 8.6mm and less than 12mm and fail the requirements of BS EN 1176 Part 1; clause 4.2.13, Chains

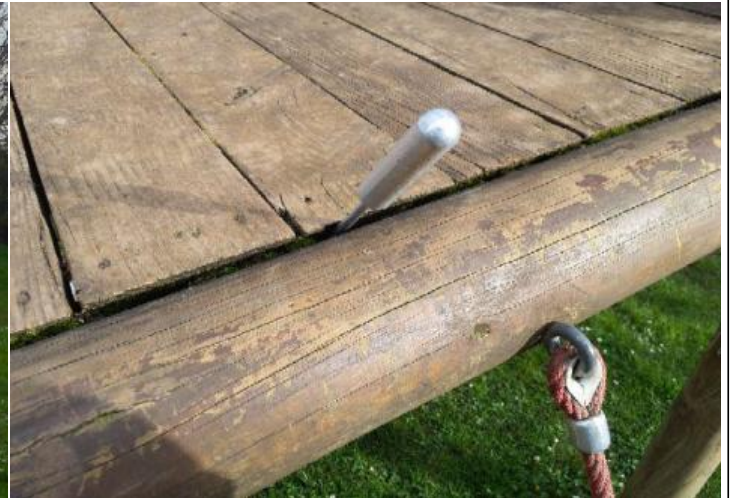
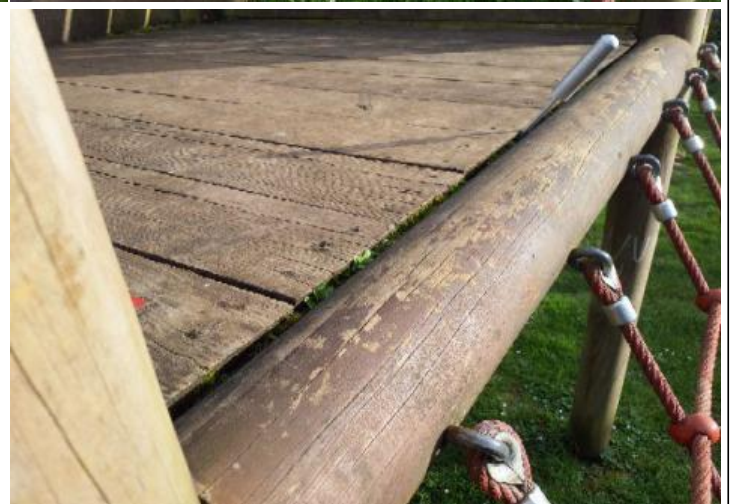
Finding: There is/are finger entrapment/s in the platform and the item fails to meet the requirements of BS EN 1176 Part 1 4.2.7.6 Entrapment of fingers

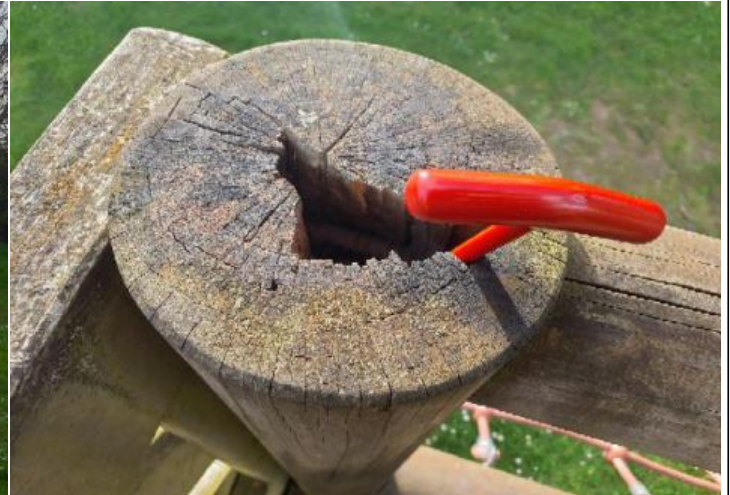
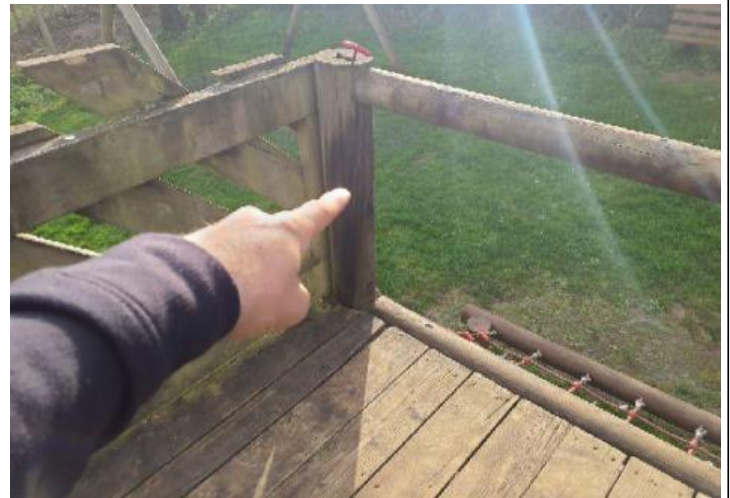
Finding: There are areas or parts of the timber on the structure that have rotted

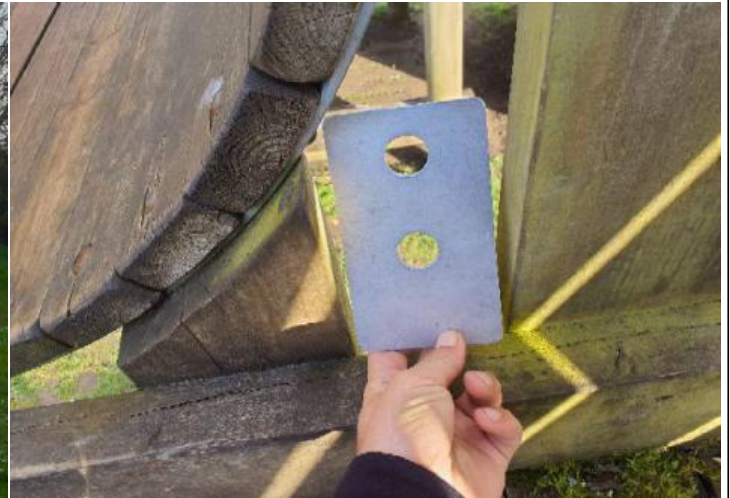
Finding: The item fails to meet the requirements of BS EN 1176 Part 1 4.2.7.2 head and neck entrapment in the barriers and/or steps

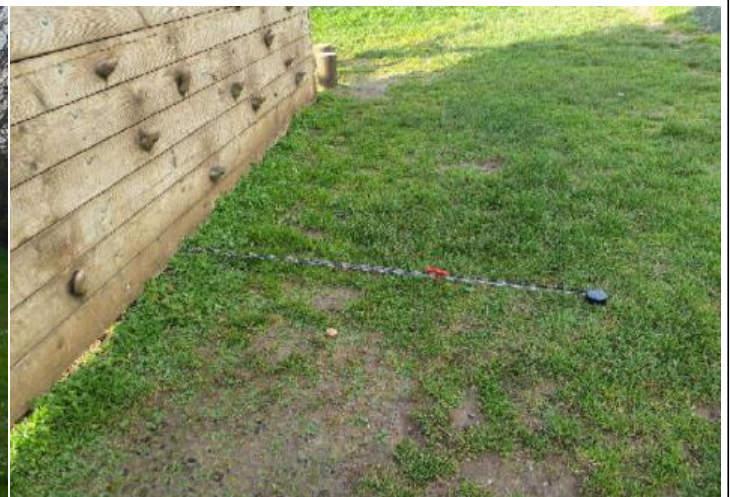
Finding: The item of equipment has a fall height exceeding 1.50 metres and grass has been provided as a safety surface, in contravention of the applicable standard (NOTE - Well maintained grass is only suitable for fall heights of upto 1.50m)

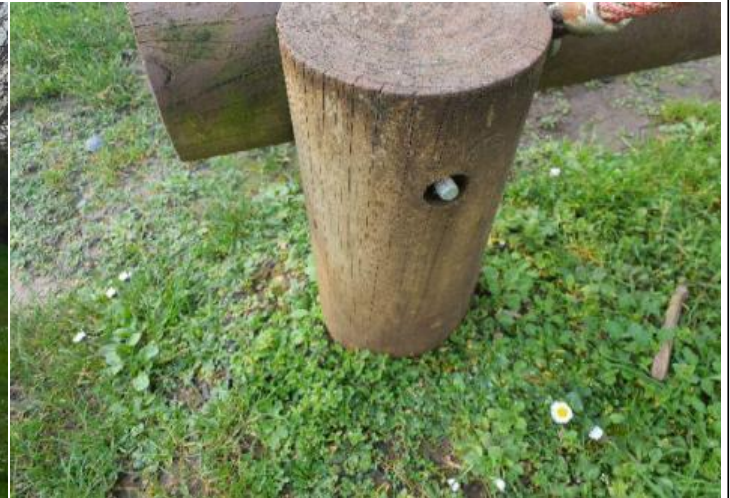
Finding: There is/are bolt cap covers missing or damaged on the item

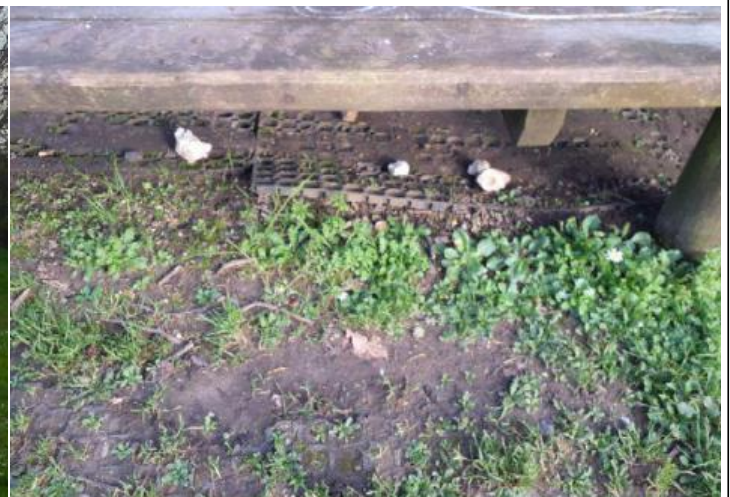
Finding: The edges of the grass mat surface are raised / lifting above the surrounding surface

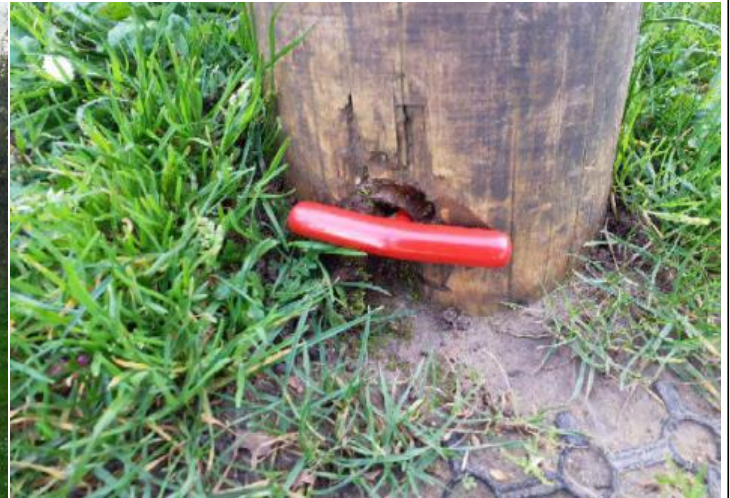
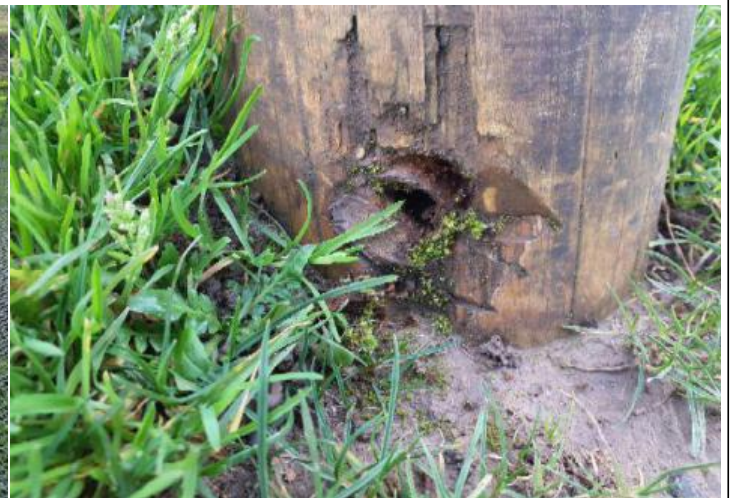
Finding: NOTE: There is a hollow rusty metal pole inside the timber

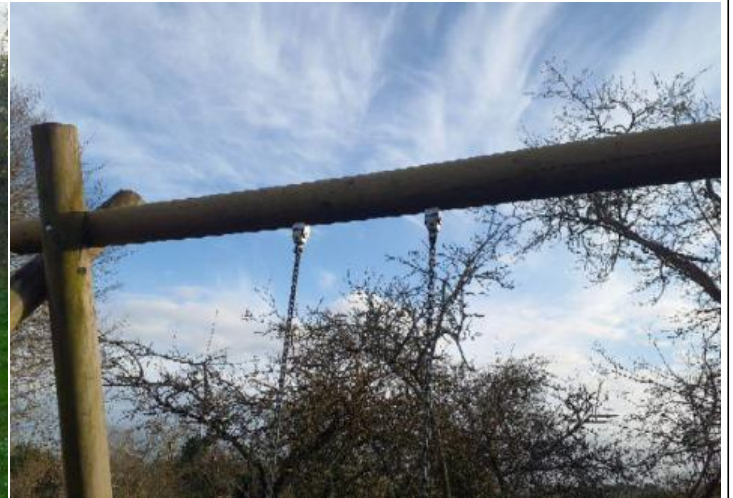
Finding: This design of swing joint has been known to fail on the weld connecting the joint to the threaded stud

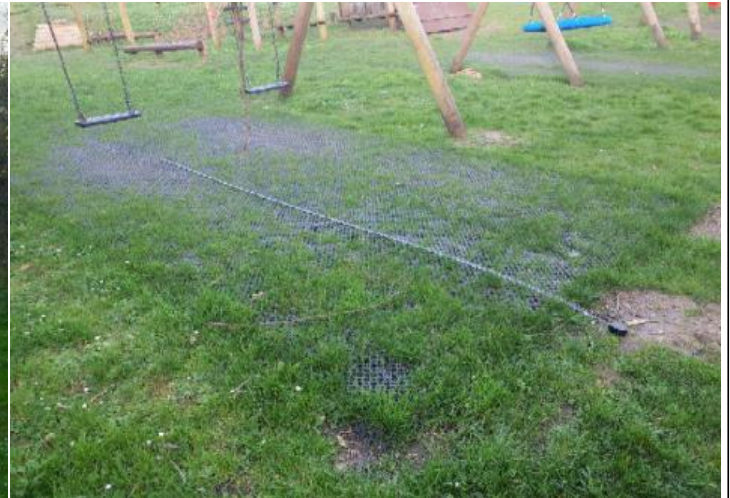
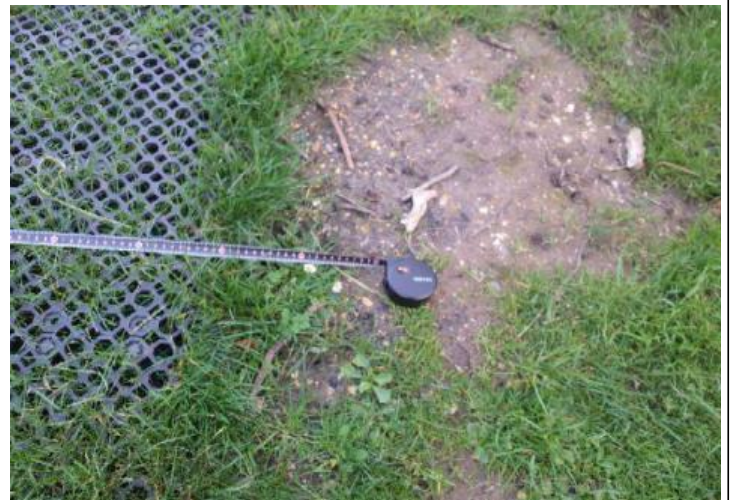
Finding: The item of equipment has a fall height exceeding 1.50 metres (1.57m) and grass has been provided as a safety surface, in contravention of the applicable standard (NOTE - Well maintained grass is only suitable for fall heights of upto 1.50m)
