the **play inspection** company

Annual Inspection

Winchester City Council

Olivers Battery Recreation Ground

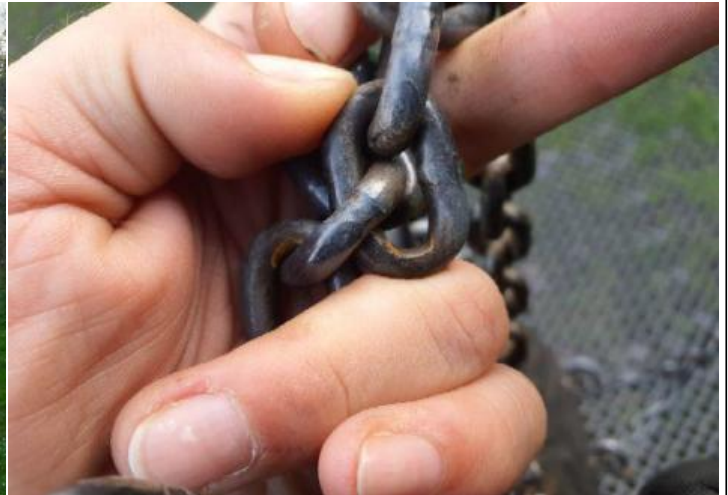
Finding: There is some notable evidence of chain wear

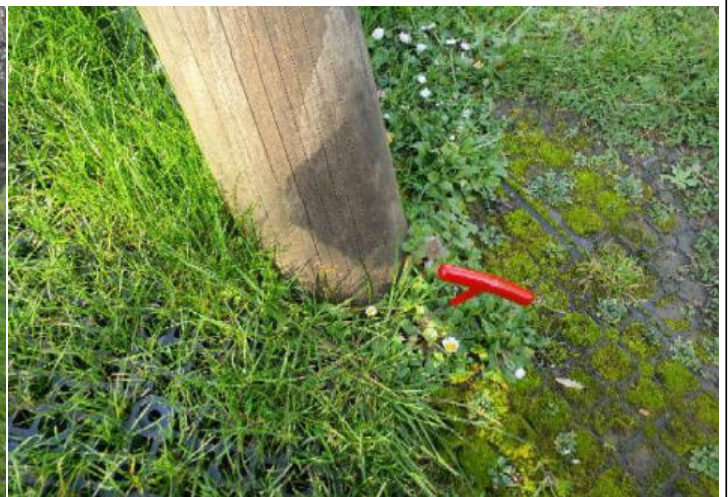
Finding: There is some evidence of rot in the timber

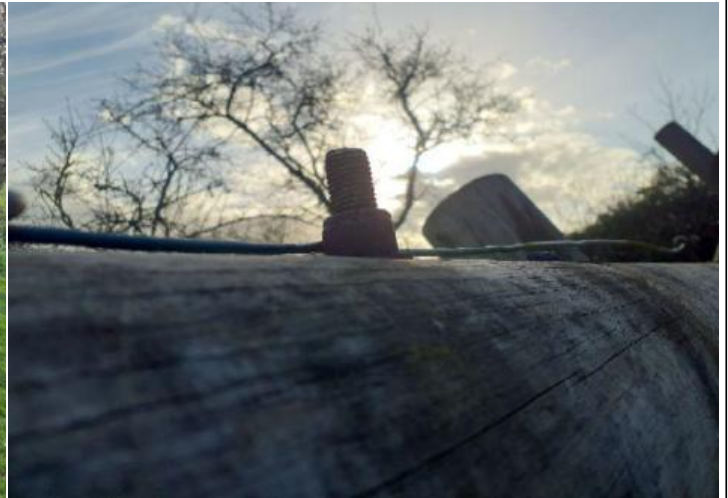
Finding: There is/are bolt cap covers missing or damaged on the item

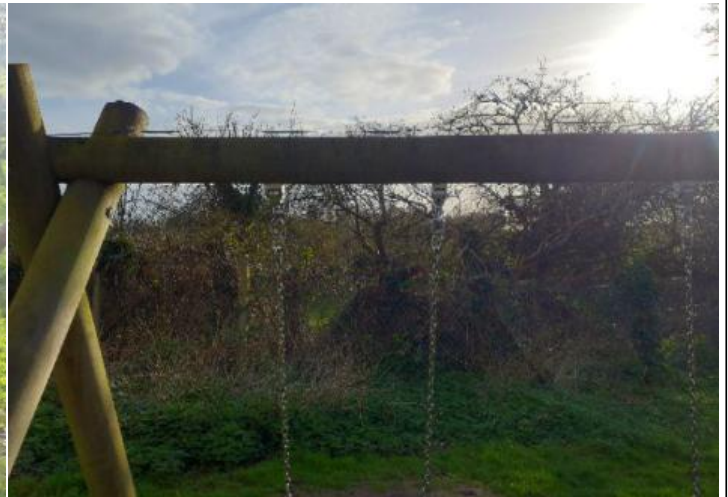
Finding: This design of swing joint has been known to fail on the weld connecting the joint to the threaded stud

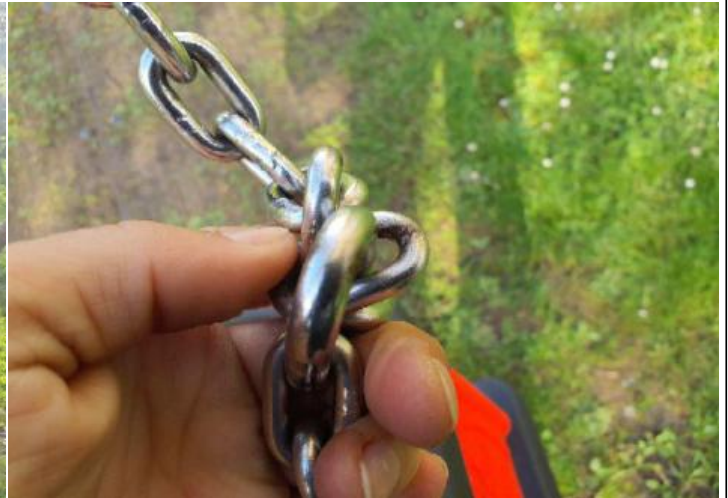
Finding: There is some notable evidence of chain wear

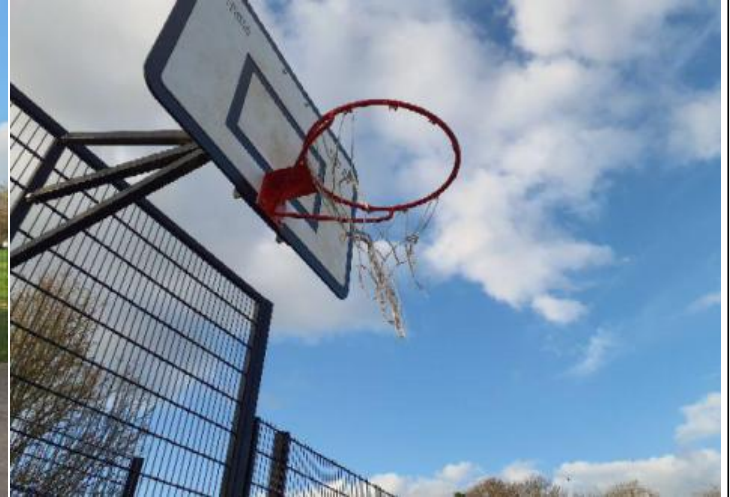
Finding: The net is severely damaged

Action: Replace

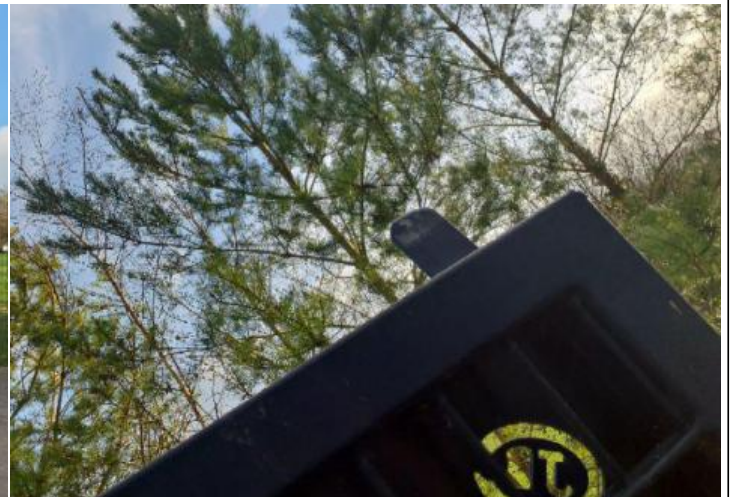
Finding: The rubber buffer is missing from the latch plate

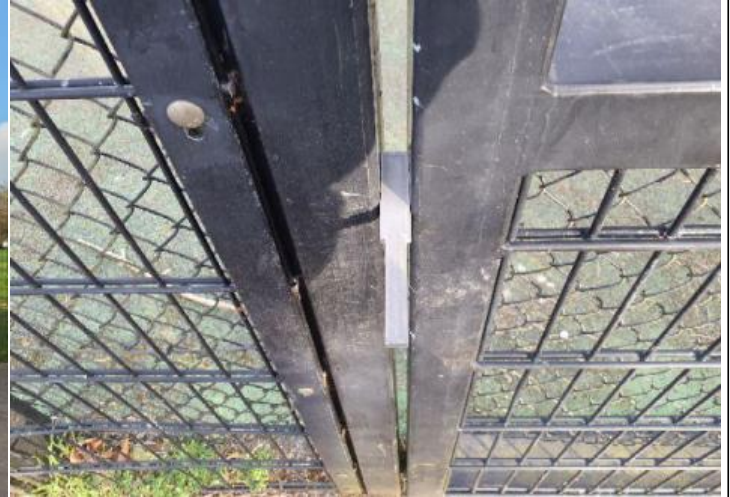
Finding: BS EN 15312 states that gaps whose dimensions change during use shall have a minimum dimension of 18mm

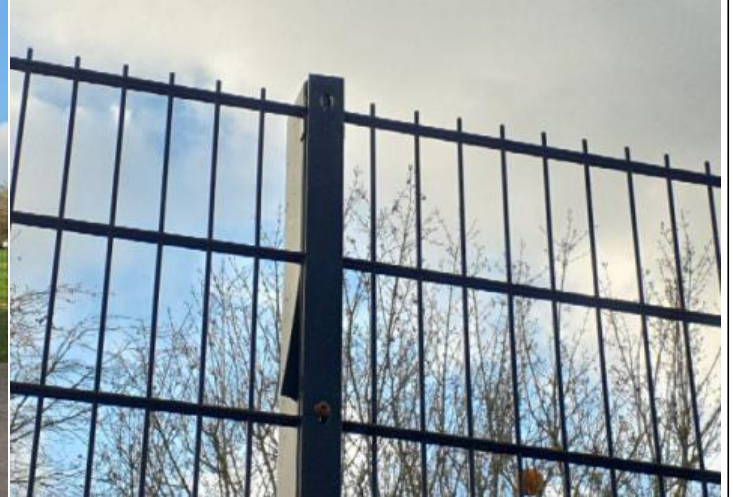
Finding: There is or are fixings missing on the item

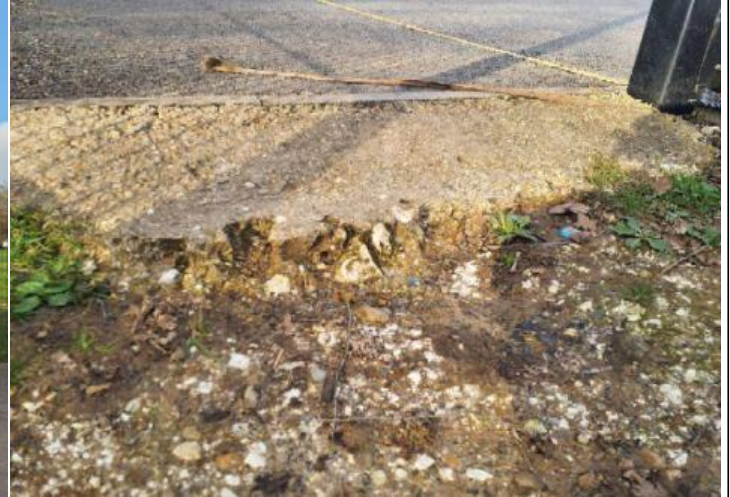
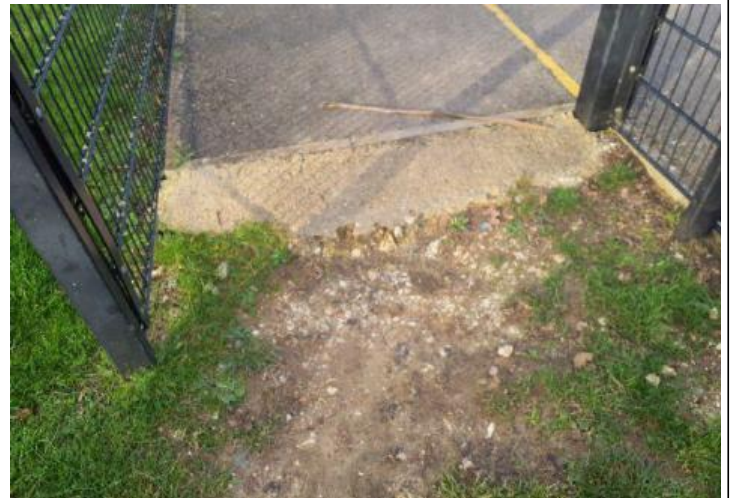
Finding: There are trip hazards present
