the **play inspection** company

Annual Inspection

Winchester City Council

Olivers Battery Recreation Ground

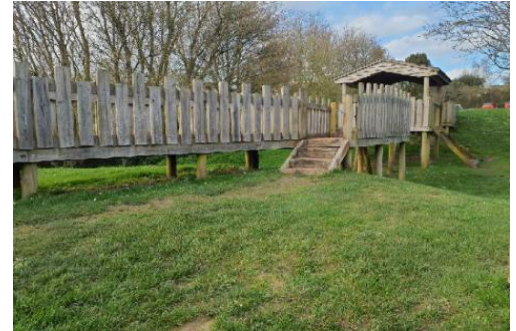
There are a number of dents in the slide surface - Monitor for any further deterioration and repair as required

There is moderate damage to the surface - Repair the damaged areas of surfacing

The surface has eroded and the foundations are exposed - Reinstate surrounding surfaces to cover the foundations

This item has no slide bar fitted as required by BS EN 1176 Part 3 - Monitor - No remedial work recommended

There is/are bolt cap covers missing or damaged on the item - Replace missing or damaged bolt cap covers

The connecting links are in excess of 8.6mm and less than 12mm and fail the requirements of BS EN 1176 Part 1; clause 4.2.13, Chains - Monitor - No remedial work recommended

There are falls in excess of 600mm between adjacent components on the structure, in contravention of the recommendations set out in BS EN 1176 Part 1; 4.2.8.4 - Monitor - No remedial work recommended

There is an opening in the barriers exceeding the width allowed (500mm) in BS EN 1176, this is a low risk failure and no remedial action is required - Monitor - No remedial work recommended

The item fails to meet the requirements of BS EN 1176 Part 1 4.2.7.2 for head and neck entrapment in the structure - Monitor - No remedial work recommended

There is/are inserts missing - Replace missing inserts

There are areas or parts of the timber on the structure that have rotted - Replace all affected timbers

There is some evidence of rot in the timber - Monitor for any further deterioration and replace as required

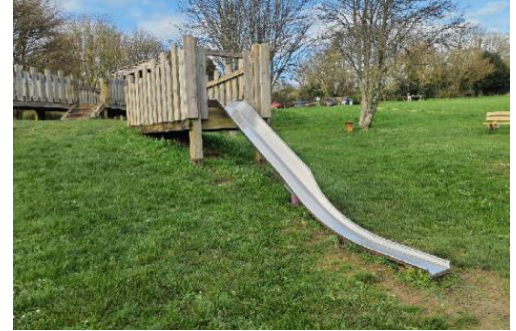
The grass mats are silted up, the soil is compacted and the area will become very slippery when the soil is wet. - Reinstate as required

There are a number of dents in the slide surface - Monitor for any further deterioration and repair as required

There is some evidence of rot in the timber - Monitor for any further deterioration and replace as required

The item fails to meet the requirements of BS EN 1176 Part 1 4.2.7.2 head and neck entrapment in the barriers and/or steps - Monitor - No remedial work recommended

There is/are finger entrapment/s in the slide starting section and the item fails to meet the requirements of BS EN 1176 Part 1 4.2.7.6 Entrapment of fingers - Monitor - No remedial work recommended

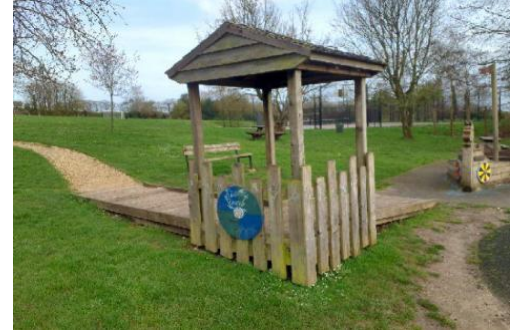
There is some graffiti present - Remove the graffiti

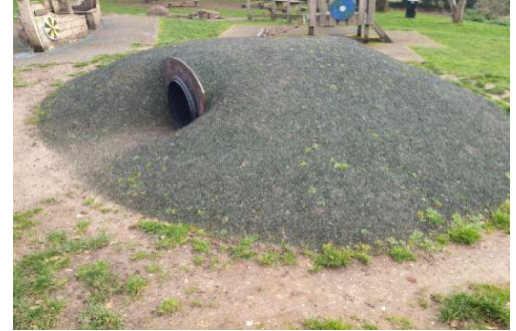
This design / configuration of tunnel mound is well established and has been successfully included in large quantities of playgrounds throughout the UK. Whilst the design does not fully meet the requirements of BS EN 1176 with regards to falls in excess of 600mm over the edge of the tunnel to the surface below, it has been risk assessed as fit for purpose in this regard and no changes are recommended to the design unless otherwise stated in additional findings - Monitor - No remedial work recommended

There is/are inserts missing - Replace missing inserts

There are gaps opening between the surfacing and the edging surround or between the joints in the surfacing - Monitor for any further deterioration and repair as required

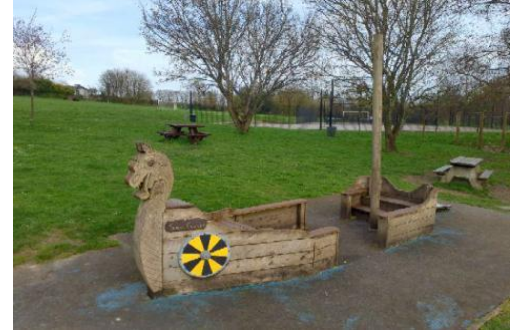
There are trip hazards at the edges of the surface - Reinstate surrounding surface levels to remove the trip points

The surfacing dimensions are short and do not meet with the requirements of the current applicable standard - Monitor - no remedial action recommended

The slide start section is less than 350mm long and fails the requirements of BS EN 1176 Part 3 - Monitor - No remedial work recommended

The lateral slide protection is less than 100mm in height and fail the requirements of BS EN 1176 Part 3 - Monitor - No remedial work recommended

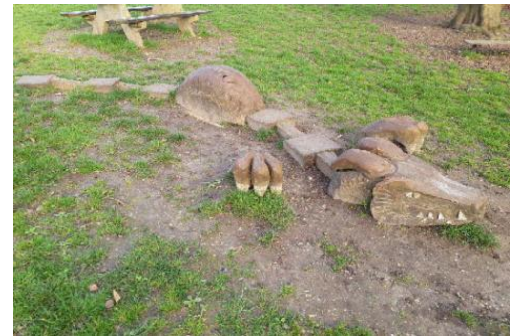
The area around the item has eroded and may become slippery - Reinstate eroded area

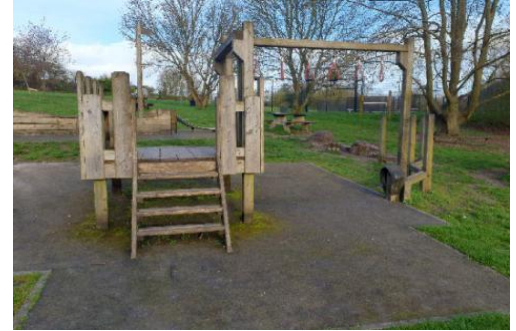
There is some minor damage to the surface - Monitor for any further deterioration and repair as required

The beam forms a projecting obstacle / hard object within the falling space of the equipment, in contravention of the requirements of BS EN 1176 Part 1 - Monitor - No remedial work recommended

The item fails to meet the requirements of BS EN 1176 Part 1 4.2.7.2 head and neck entrapment in the barriers and/or steps - Monitor - No remedial work recommended

The connecting links are in excess of 8.6mm and less than 12mm and fail the requirements of BS EN 1176 Part 1; clause 4.2.13, Chains - Monitor - No remedial work recommended

The picnic table / sculpture forms a projecting obstacle / hard object within the falling space of the equipment, in contravention of the requirements of BS EN 1176 Part 1 - Monitor - No remedial work recommended

The surfacing dimensions are short and do not meet with the requirements of the current applicable standard - Monitor - no remedial action recommended

There is some evidence of rot in the timber - Monitor for any further deterioration and replace as required

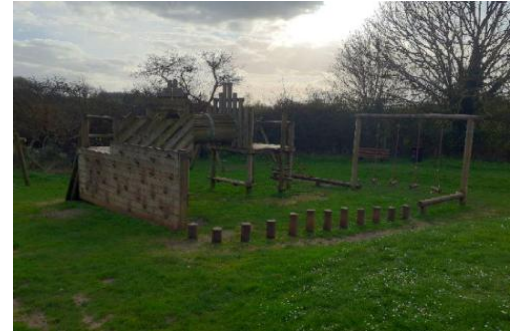
The grass mats are silted up, the soil is compacted and the area will become very slippery when the soil is wet. - Reinstate as required

There is some evidence of rot in the timber - Monitor for any further deterioration and replace as required

The ropes/nets are worn/damaged in places - Monitor for any further deterioration and repair or replace as required

There is some notable evidence of connecting link wear - Monitor for any further deterioration and replace when 40% worn

There are falls in excess of 600mm between adjacent components on the structure, in contravention of the recommendations set out in BS EN 1176 Part 1; 4.2.8.4 - Monitor - No remedial work recommended

The connecting links are in excess of 8.6mm and less than 12mm and fail the requirements of BS EN 1176 Part 1; clause 4.2.13, Chains - Monitor - No remedial work recommended

There is/are finger entrapment/s in the platform and the item fails to meet the requirements of BS EN 1176 Part 1 4.2.7.6 Entrapment of fingers - Remove the entrapment

There are areas or parts of the timber on the structure that have rotted - Replace all affected timbers

The item fails to meet the requirements of BS EN 1176 Part 1 4.2.7.2 head and neck entrapment in the barriers and/or steps - Monitor - No remedial work recommended

There is/are bolt cap covers missing or damaged on the item - Replace missing or damaged bolt cap covers

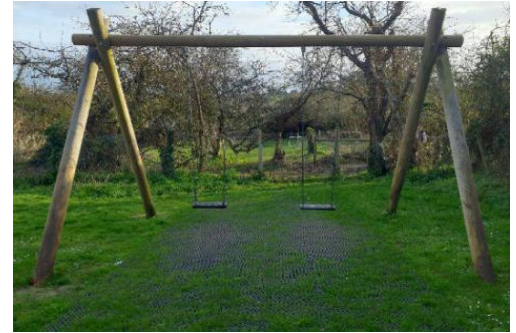
Finding 1
 NOTE: There is a hollow rusty metal pole inside the timber - Refer to manufacturer as to the timber's suitability

Finding 2
 This design of swing joint has been known to fail on the weld connecting the joint to the threaded stud - We would recommend that the joint be dismantled and checked on a regular basis or consulting with manufacturer on whether a Secondary Safety Device can be fitted

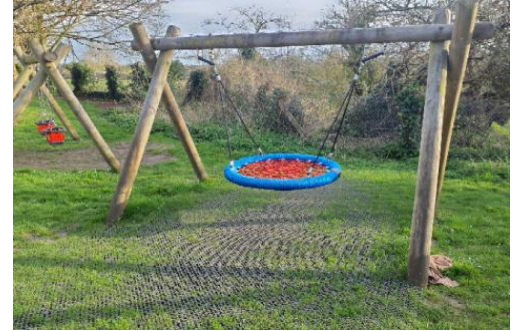
There is some evidence of rot in the timber - Monitor for any further deterioration and replace as required

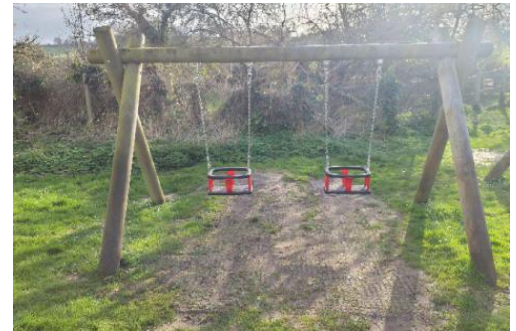
This design of swing joint has been known to fail on the weld connecting the joint to the threaded stud - We would recommend that the joint be dismantled and checked on a regular basis or consulting with manufacturer on whether a Secondary Safety Device can be fitted

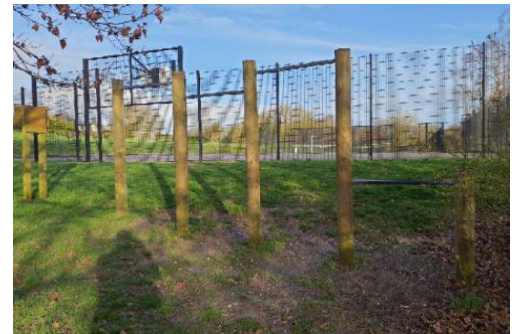
The adjacent foliage is overhanging - Cut back and maintain

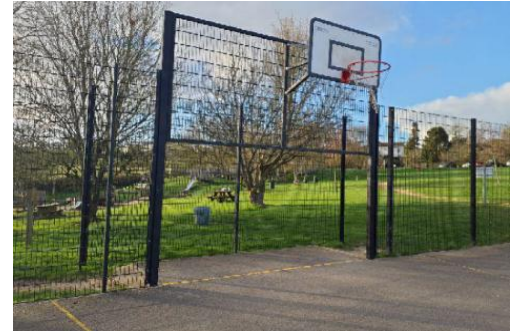
A clearly visible facility sign should be provided in a prominent position with the wording as detailed BS EN 15312- the equipment is not intended for children less than 3 years old- the warning - Do not climb on the framework or nets- the warning - Do not hang on the ring (if provided)- the warning - Do not wear rings or other jewellery- name and telephone number of the administrator- number to call in case of accident - Provide signage to BS EN 15312

The net is severely damaged - Replace

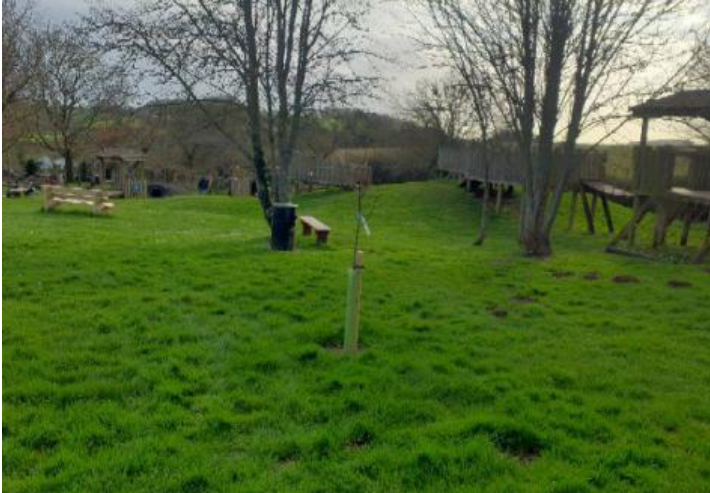
8 - Low Risk (Finding 1)			
Item:	Ancillary Items - Site General	Risk Level:	L - Low Risk
Manufacturer:	Owner/Operator	Surface:	N/A

Finding: There are molehills in the area		Action: Remove and reinstate surface to level

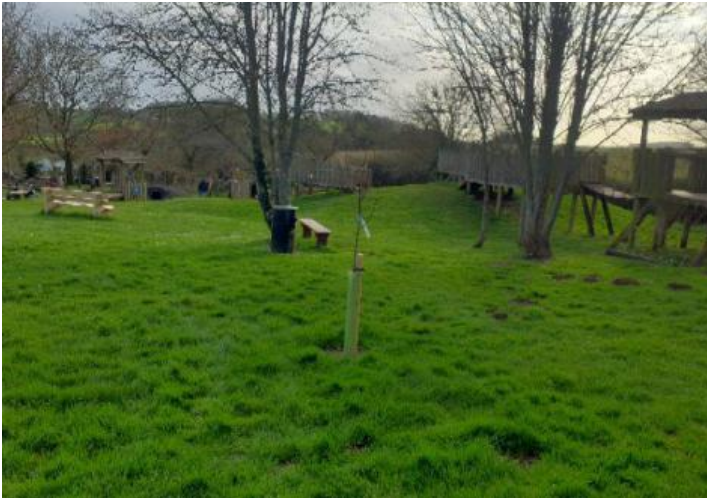
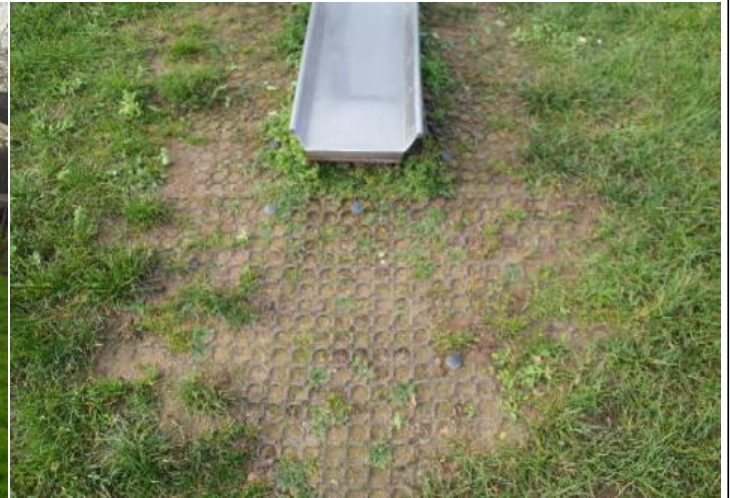
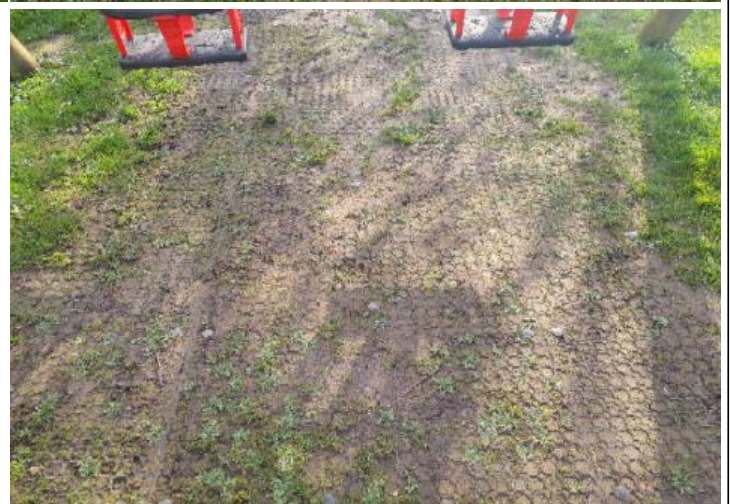
i 5 - Very Low Risk (Finding 2)

Finding: Fixing Pins have been installed in the impact areas of the grass mats
Action: Remove pins from impact areas

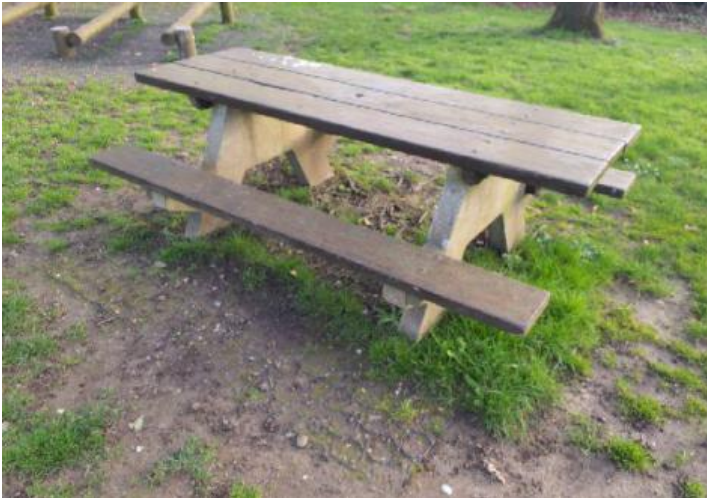
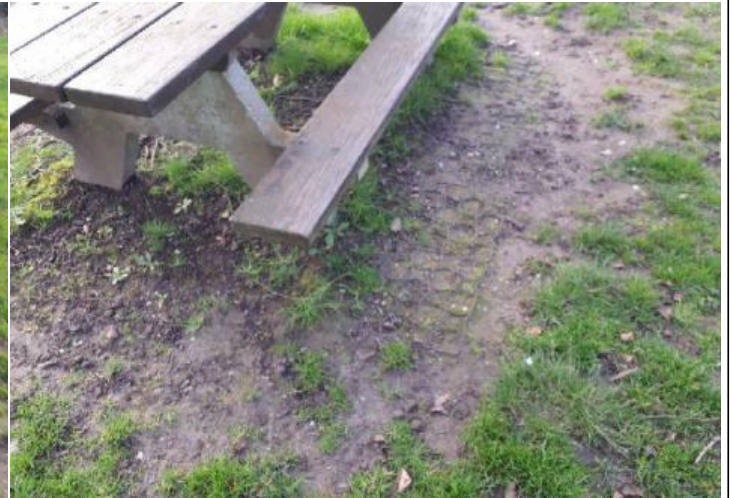
i 8 - Low Risk (Finding 1)

Finding: The grass mats are silted up, the soil is compacted and the area will become very slippery when the soil is wet. **Action:** Reinstate as required

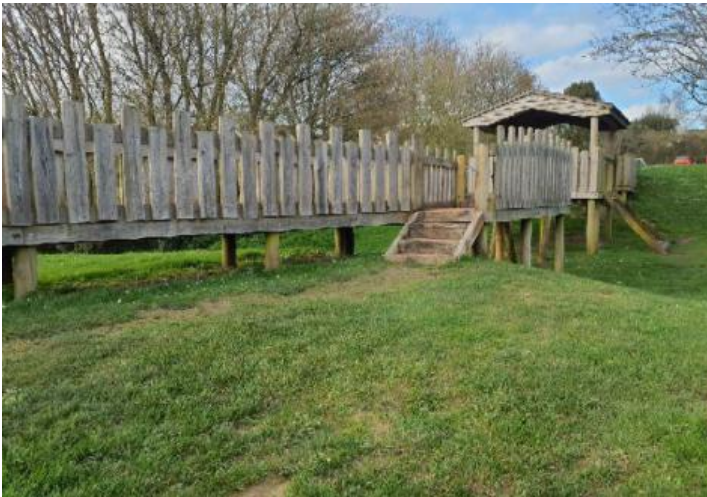
i 4 - Very Low Risk (Finding 1)

Finding: There are a number of dents in the slide surface **Action:** Monitor for any further deterioration and repair as required

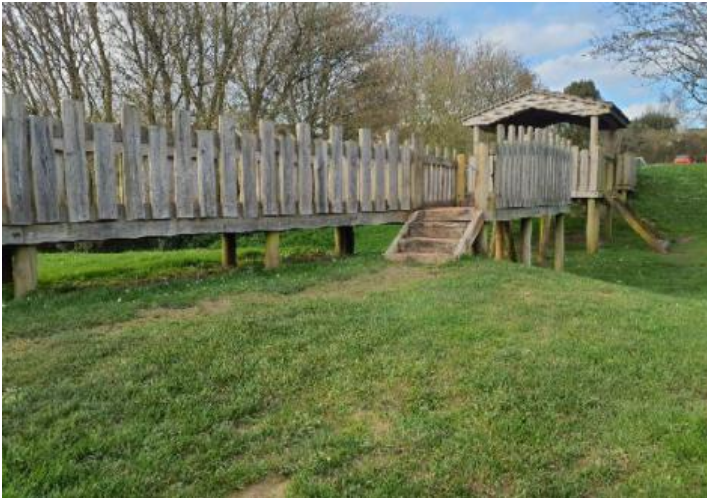
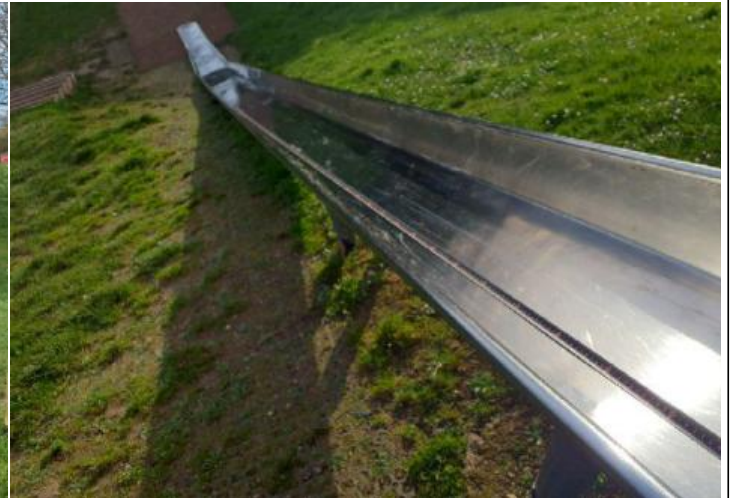
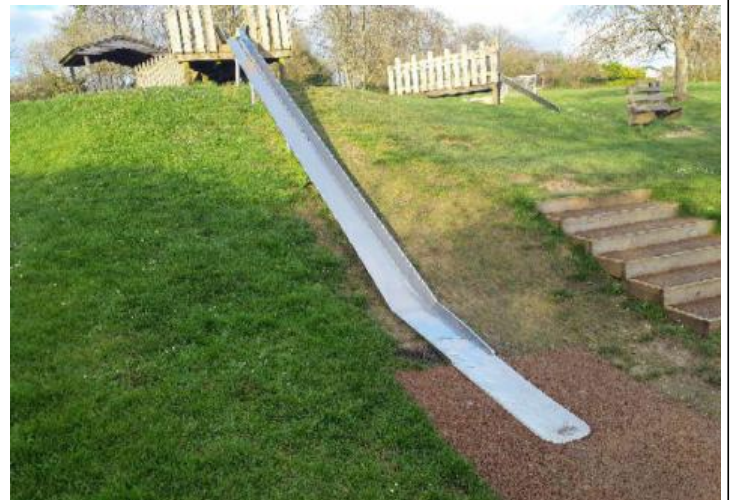
i 8 - Low Risk (Finding 2)

Finding: The length of the sliding section exceeds 7500mm (length = 8500mm) in contravention of BS EN 1176 Part 3 **Action:** Monitor use - no further action required

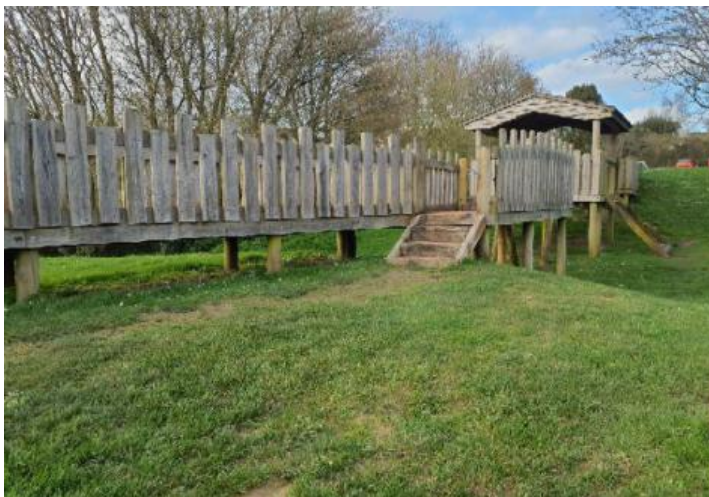
Finding: This item has no slide bar fitted as required by BS EN 1176 Part 3

Action: Monitor - No remedial work recommended

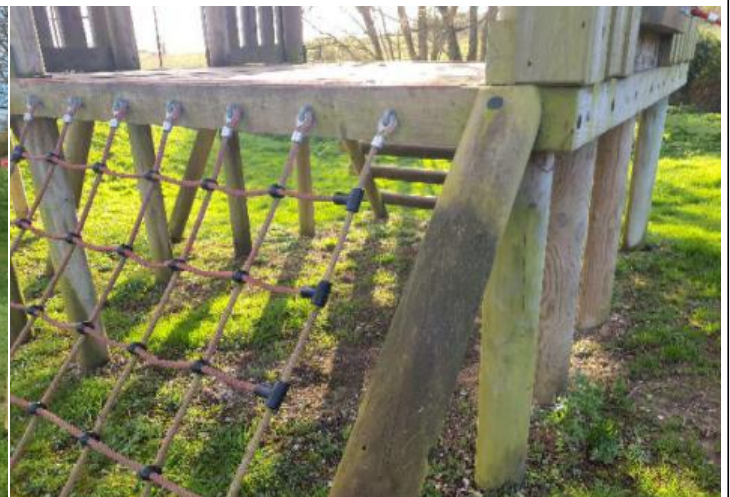
Finding: There is algae or moss on the surface of the equipment

Action: Clean and treat appropriately

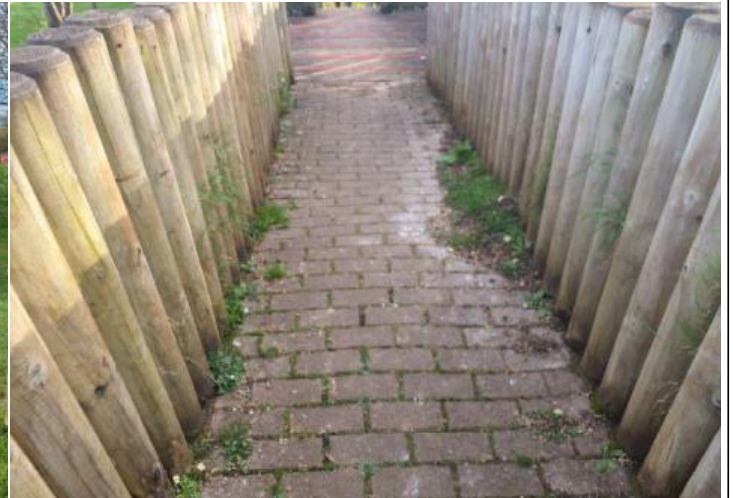
Finding: There is weed / vegetation growth on, between, or around the edges of the surfacing
Action: Remove weed / vegetation growth

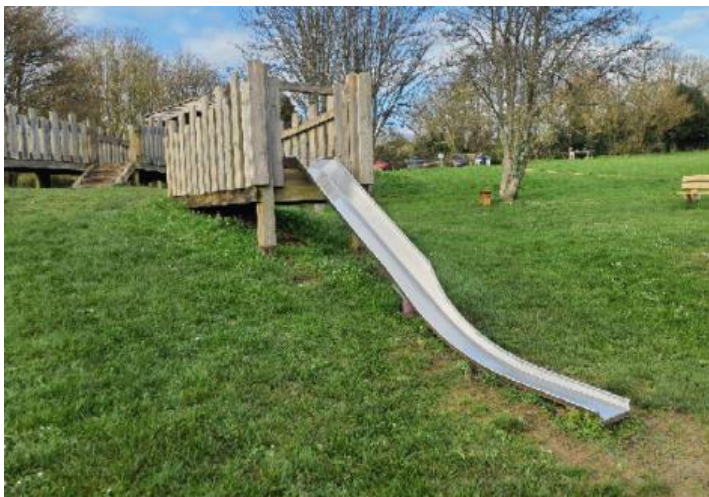
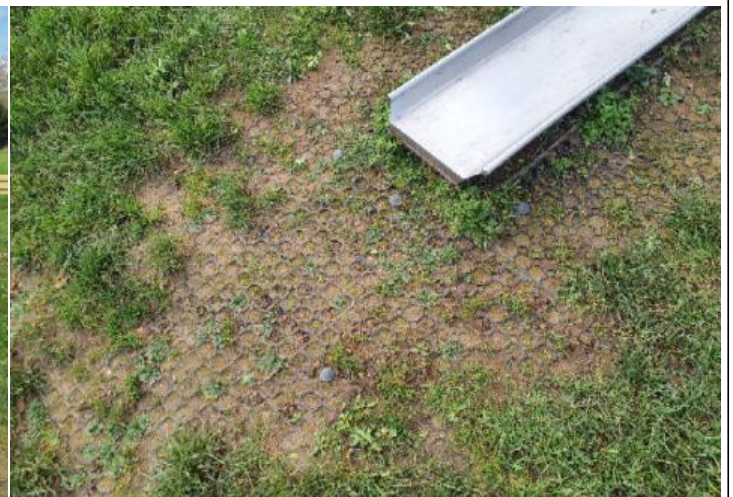
i 8 - Low Risk (Finding 1)

Finding: The grass mats are silted up, the soil is compacted and the area will become very slippery when the soil is wet.
Action: Reinstate as required

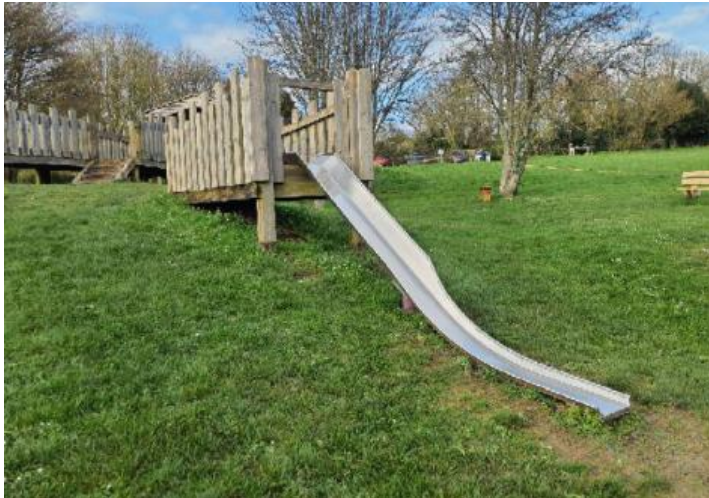
Finding: There are a number of dents in the slide surface

Action: Monitor for any further deterioration and repair as required

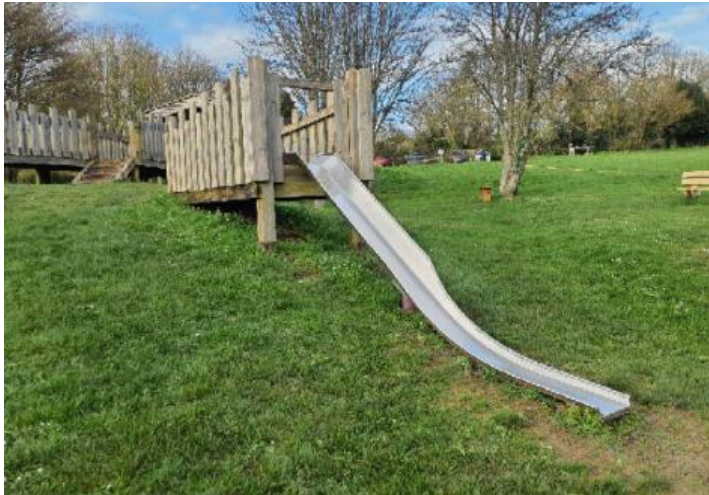
Finding: The item fails to meet the requirements of BS EN 1176 Part 1 4.2.7.2 head and neck entrapment in the barriers and/or steps

Action: Monitor - No remedial work recommended

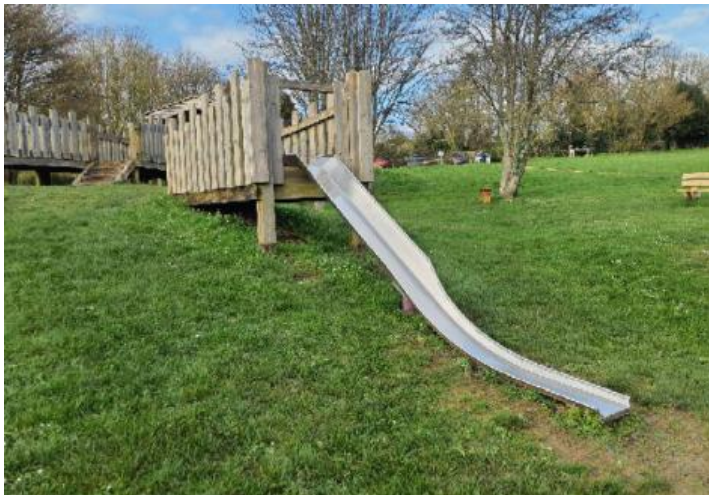
Finding: There is/are finger entrapment/s in the slide starting section and the item fails to meet the requirements of BS EN 1176 Part 1 4.2.7.6 Entrapment of fingers

Action: Monitor - No remedial work recommended

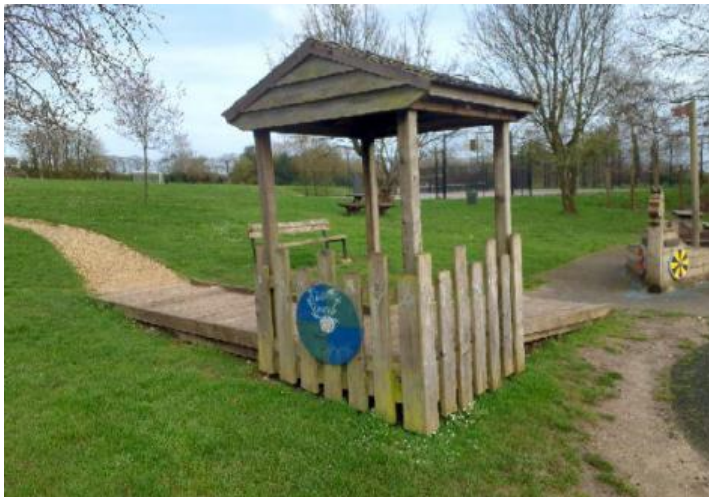
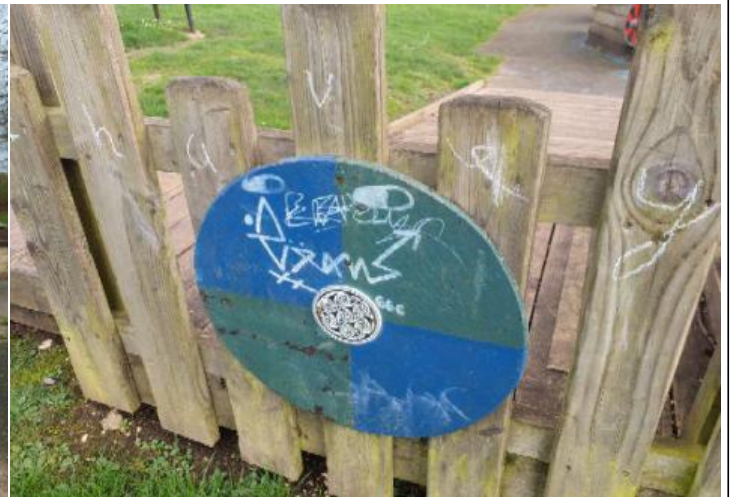
Finding: There is some graffiti present

Action: Remove the graffiti

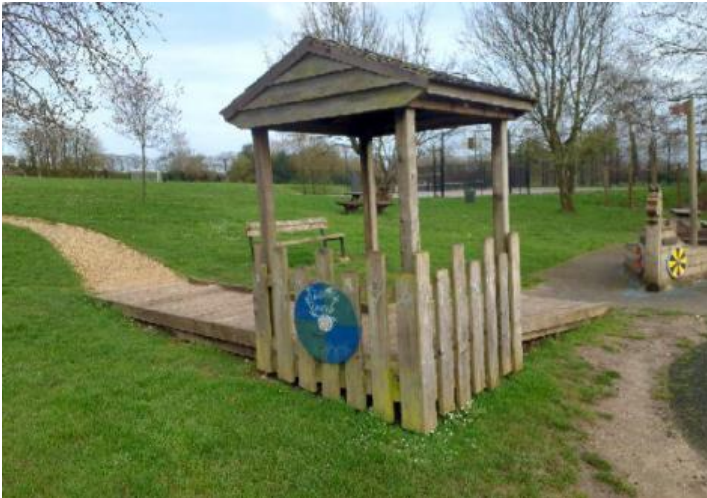
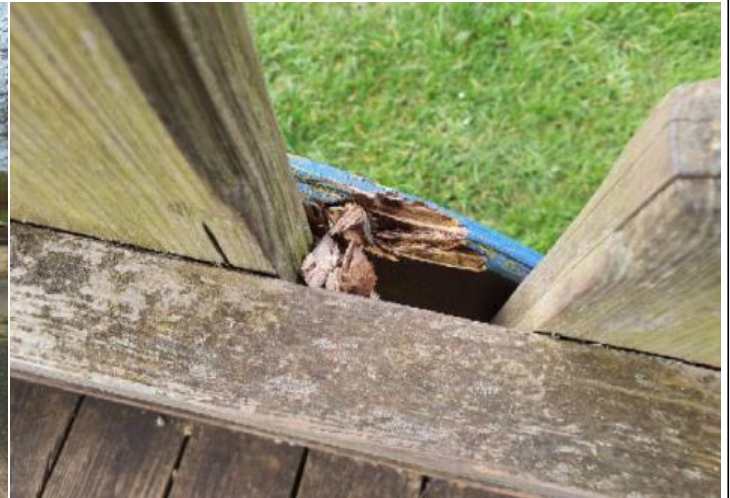
Finding: Parts of the timber are rough or splintered

Action: Remove all rough or sharp edges

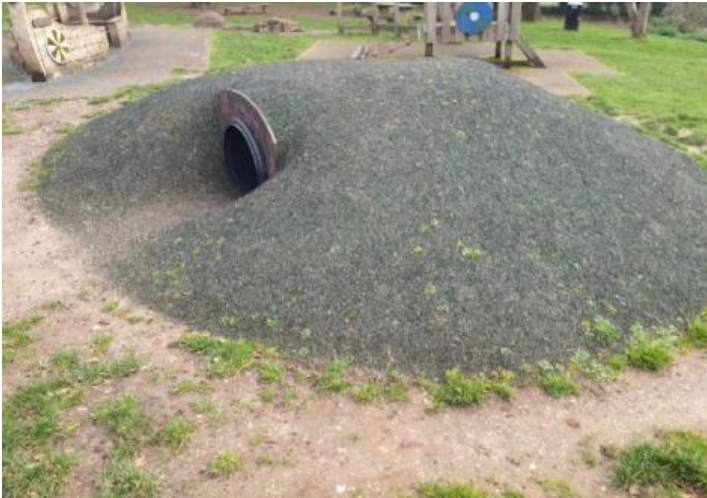
Finding: This design / configuration of tunnel mound is well established and has been successfully included in large quantities of playgrounds throughout the UK. Whilst the design does not fully meet the requirements of BS EN 1176 with regards to falls in excess of 600mm over the edge of the tunnel to the surface below, it has been risk assessed as fit for purpose in this regard and no changes are recommended to the design unless otherwise stated in additional findings

Action: Monitor - No remedial work recommended

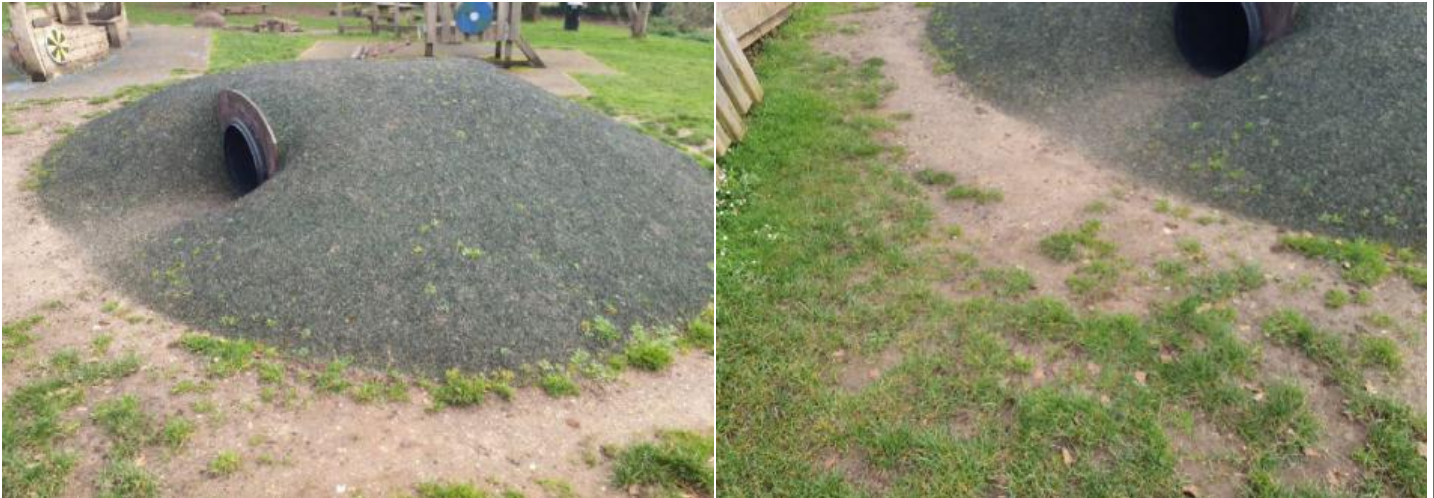
i 8 - Low Risk (Finding 2)

Finding: The area around the item has eroded and may become slippery	Action: Reinststate eroded area
---	--

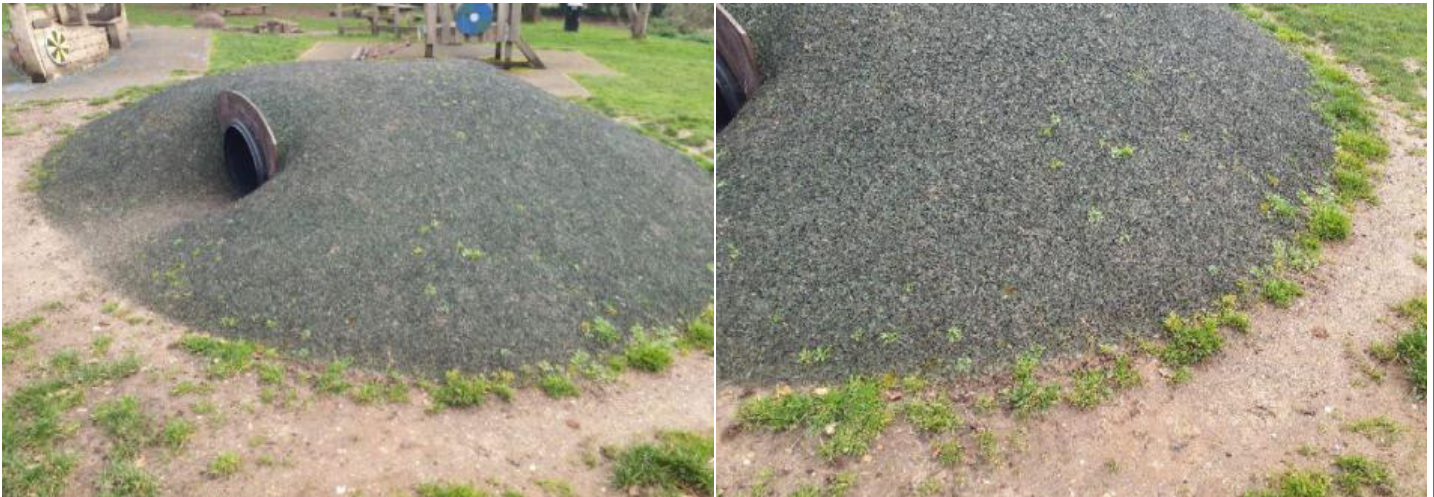
i 6 - Low Risk (Finding 3)

Finding: There is weed / vegetation growth on, between, or around the edges of the surfacing	Action: Remove weed / vegetation growth
---	--

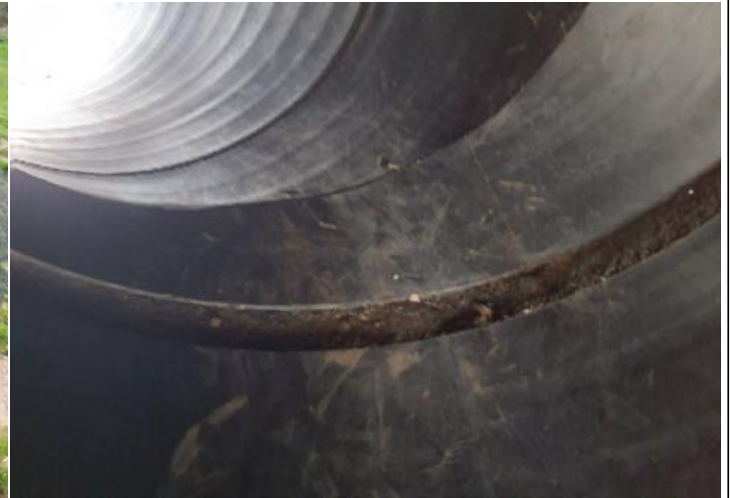
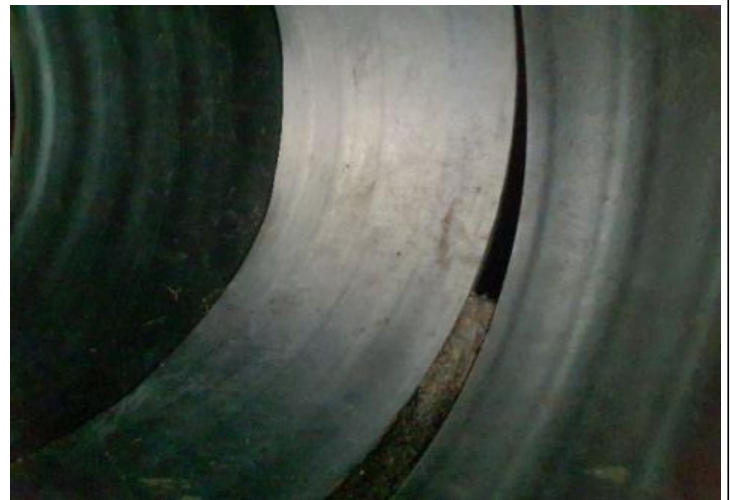
Finding: There are gaps in the tunnel sections

Action: Fill the gaps to level

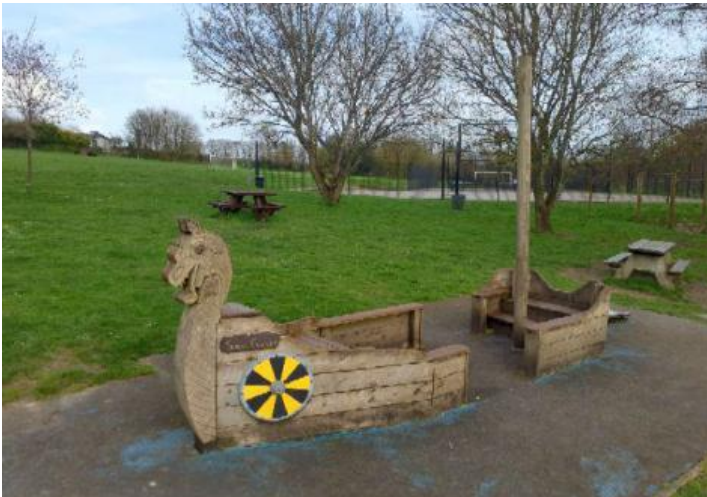
Finding: There are trip hazards at the edges of the surface
Action: Reinstate surrounding surface levels to remove the trip points

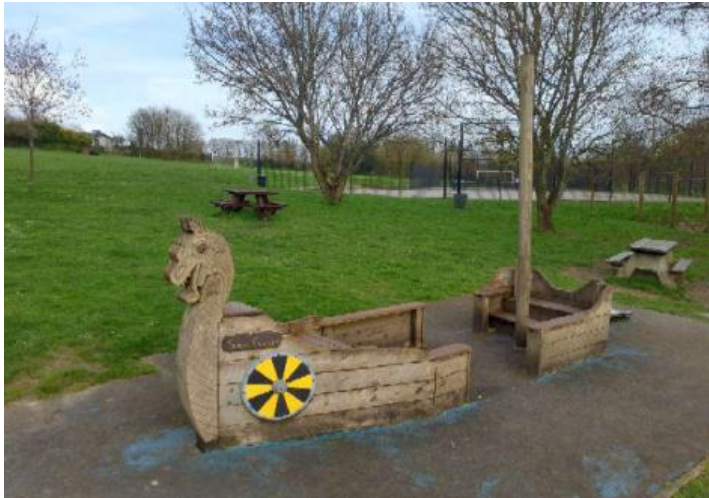
i 5 - Very Low Risk (Finding 2)

Finding: The surfacing dimensions are short and do not meet with the requirements of the current applicable standard

Action: Monitor - no remedial action recommended

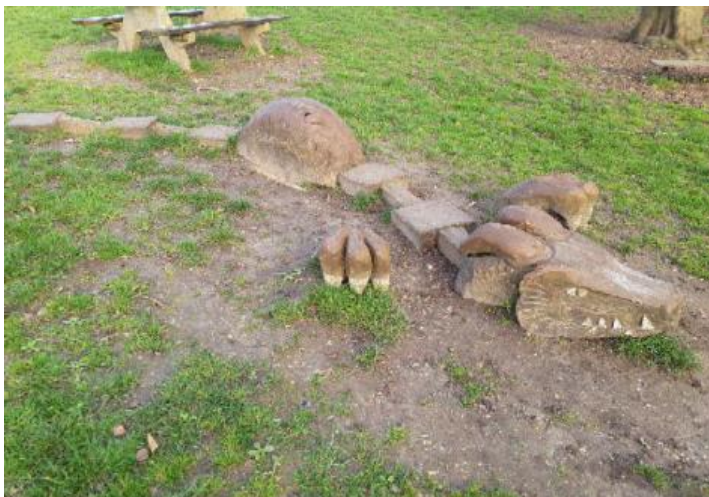
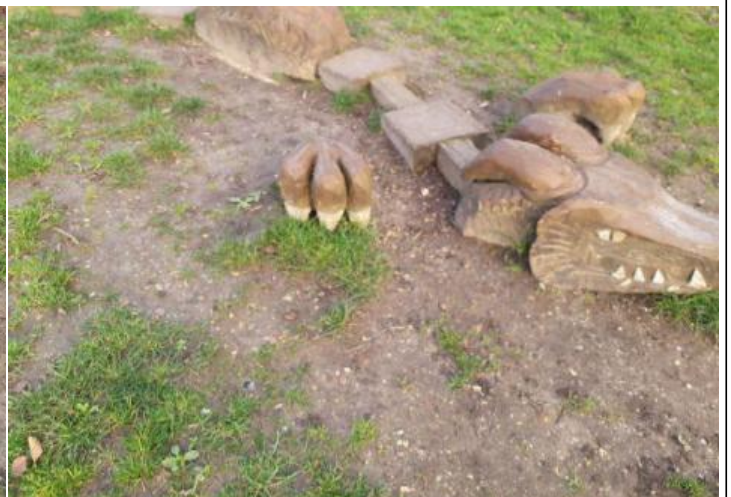
Finding: The area around the item has eroded and may become slippery

Action: Reinstate eroded area

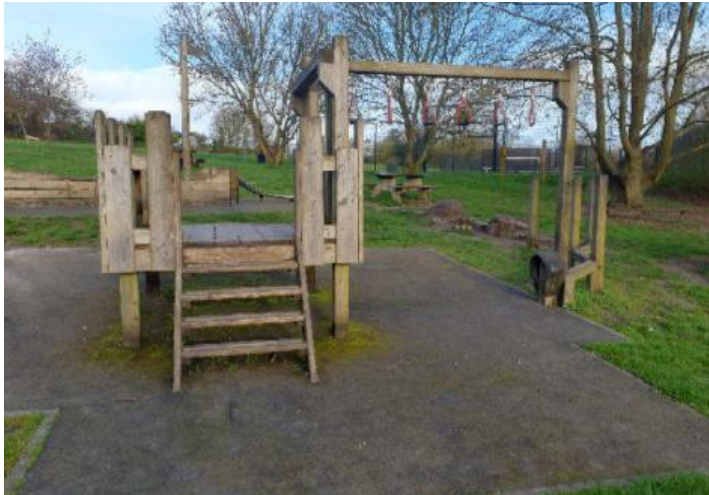
Finding: There is some minor damage to the surface

Action: Monitor for any further deterioration and repair as required

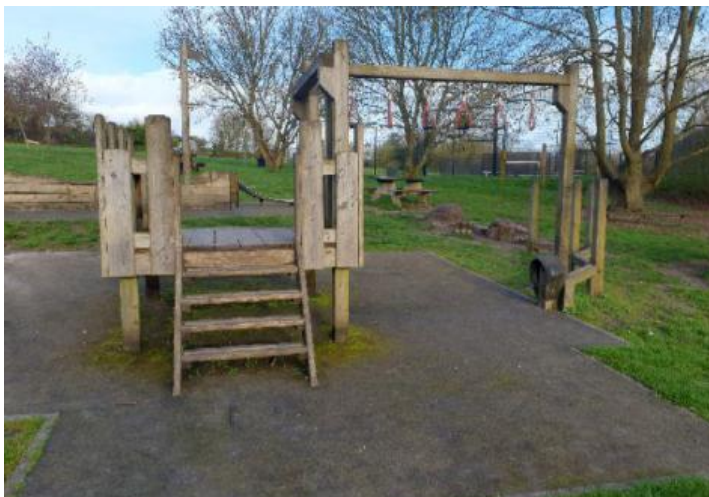
Finding: The beam forms a projecting obstacle / hard object within the falling space of the equipment, in contravention of the requirements of BS EN 1176 Part 1

Action: Monitor - No remedial work recommended

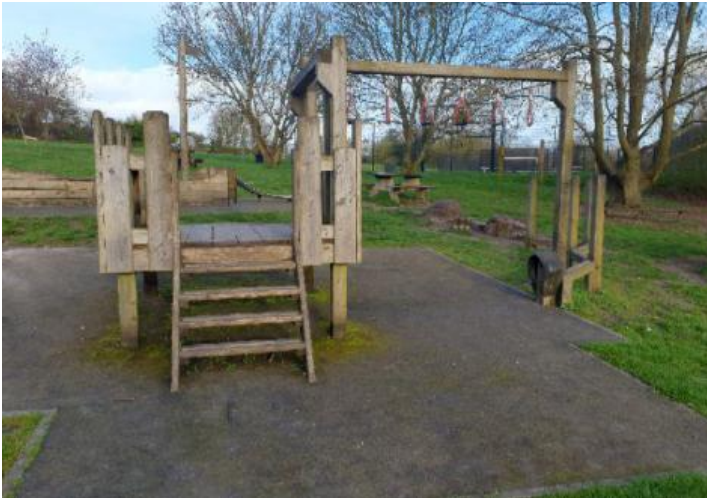
Finding: The item fails to meet the requirements of BS EN 1176 Part 1 4.2.7.2 head and neck entrapment in the barriers and/or steps

Action: Monitor - No remedial work recommended

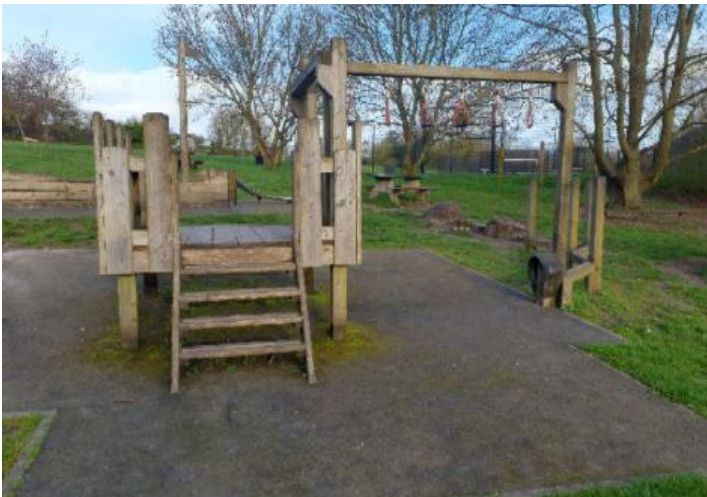
Finding: The connecting links are in excess of 8.6mm and less than 12mm and fail the requirements of BS EN 1176 Part 1; clause 4.2.13, Chains

Action: Monitor - No remedial work recommended

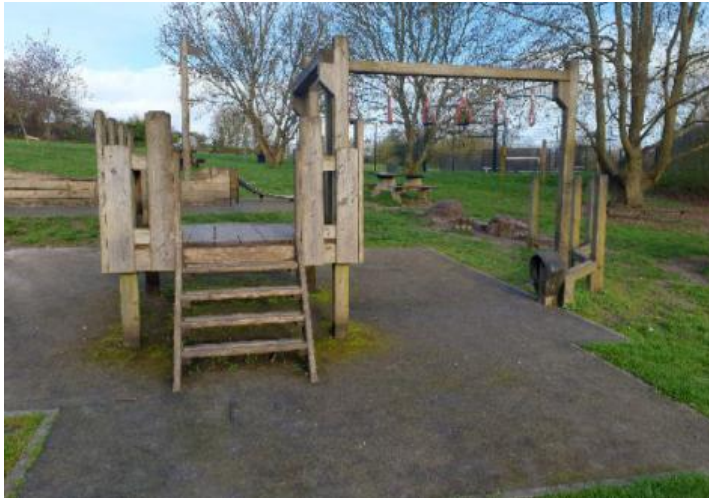
Finding: The picnic table / sculpture forms a projecting obstacle / hard object within the falling space of the equipment, in contravention of the requirements of BS EN 1176 Part 1

Action: Monitor - No remedial work recommended

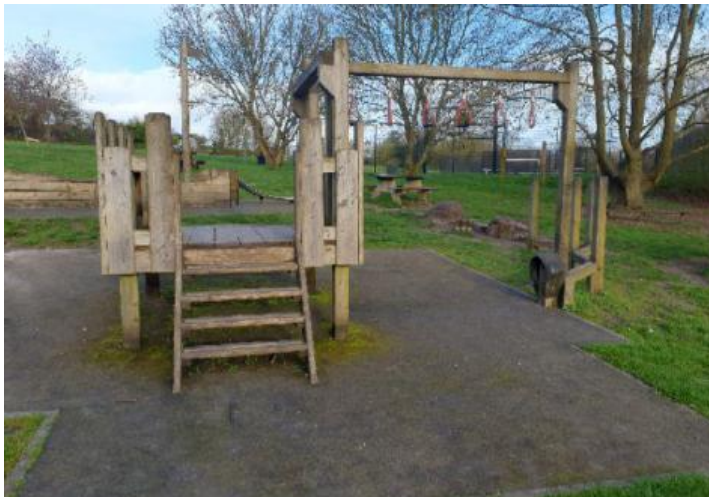
Finding: There is some evidence of rot in the timber

Action: Monitor for any further deterioration and replace as required

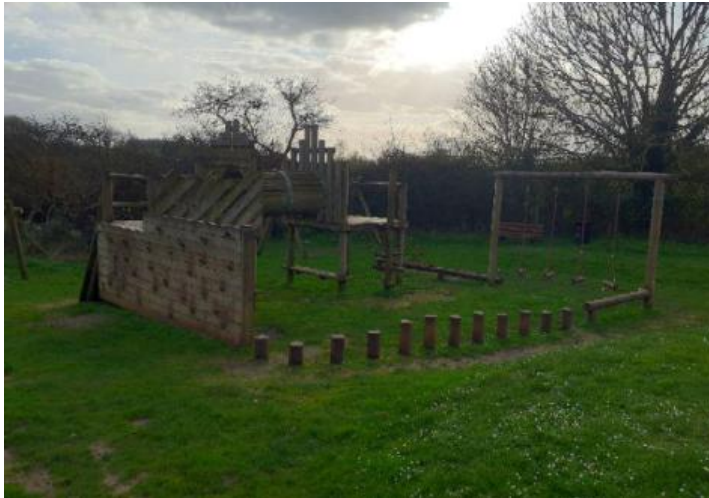
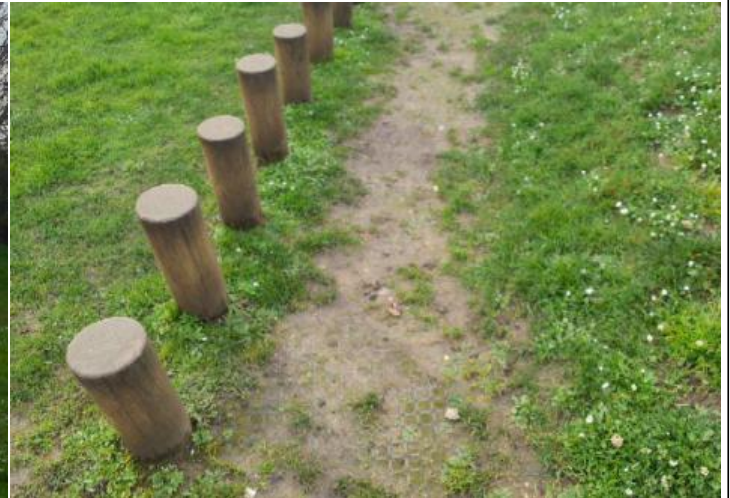
Finding: The grass mats are silted up, the soil is compacted and the area will become very slippery when the soil is wet. **Action:** Reinststate as required

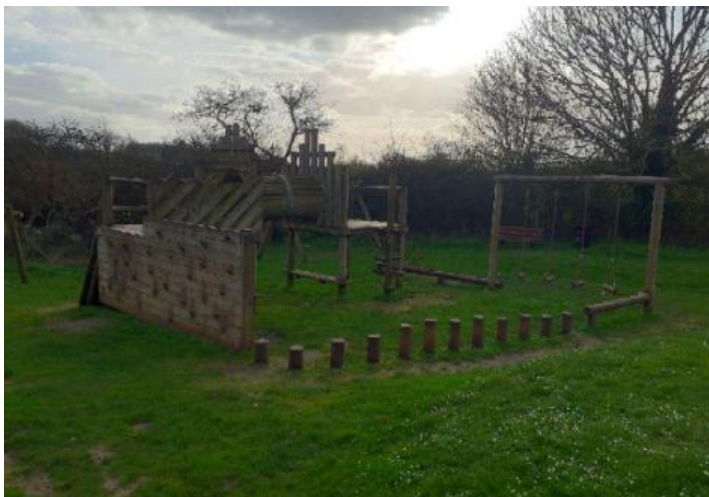
i 6 - Low Risk (Finding 2)

Finding: There is some evidence of rot in the timber **Action:** Monitor for any further deterioration and replace as required

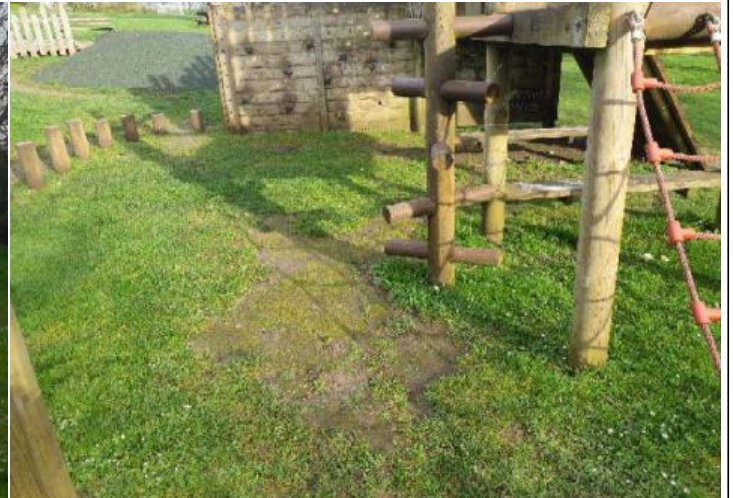
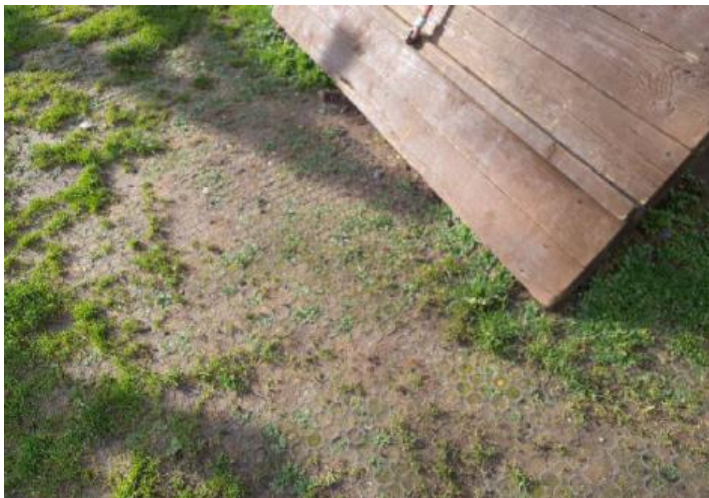
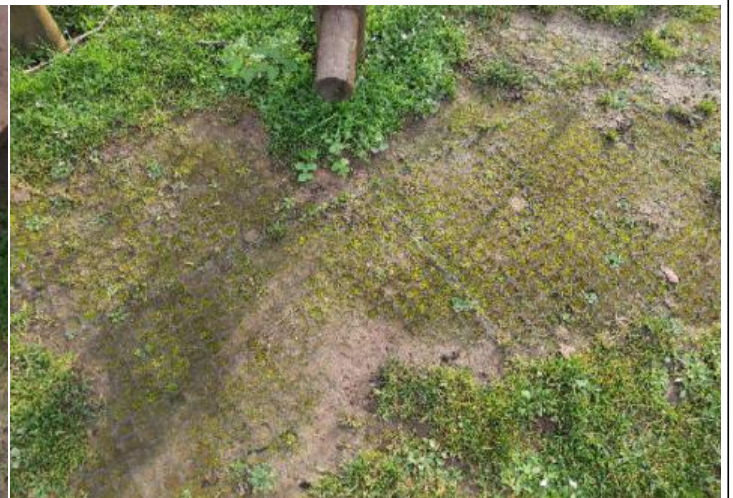
Finding: The grass mats are silted up and the soil is compacted; this may have an effect on the impact absorbing properties of the surface. Consideration should be given to HIC testing the surface to verify impact attenuating properties (<https://playinspections.co.uk/inspection-services/safety-surface-testing/>)

Action: Contact our office for a quotation for this service

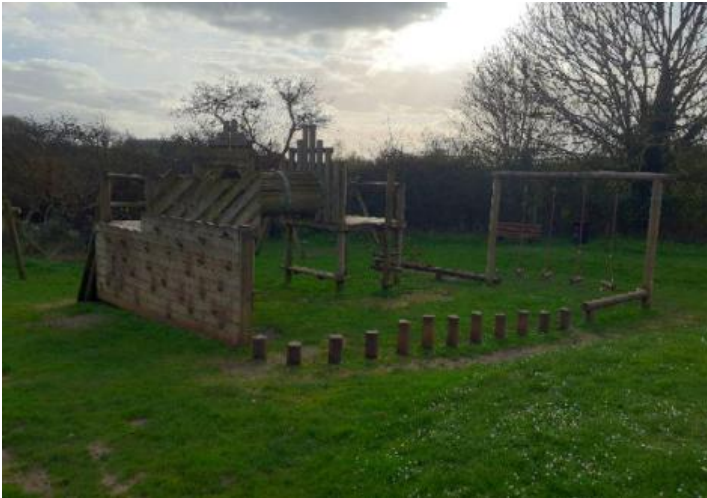
Finding: There is/are finger entrapment/s in the platform and the item fails to meet the requirements of BS EN 1176 Part 1 4.2.7.6 Entrapment of fingers

Action: Remove the entrapment

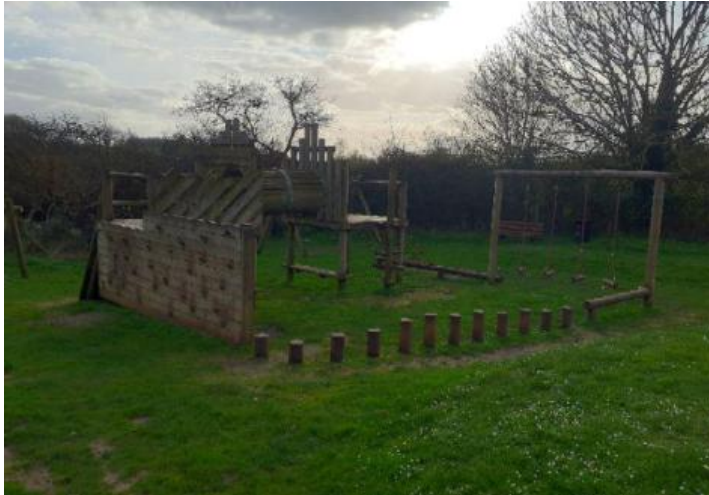
Finding: There are areas or parts of the timber on the structure that have rotted

Action: Replace all affected timbers
