the **play inspection** company

Annual Inspection

Winchester City Council

Olivers Battery Recreation Ground

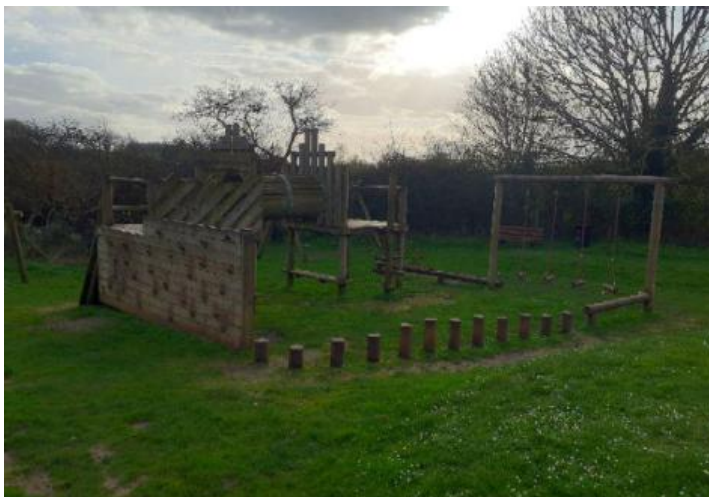
The item of equipment has a fall height exceeding 1.50 metres and grass has been provided as a safety surface, in contravention of the applicable standard (NOTE - Well maintained grass is only suitable for fall heights of upto 1.50m) - Monitor - no remedial action recommended

Finding: The item of equipment has a fall height exceeding 1.50 metres and grass has been provided as a safety surface, in contravention of the applicable standard (NOTE - Well maintained grass is only suitable for fall heights of upto 1.50m)

Action: Monitor - no remedial action recommended

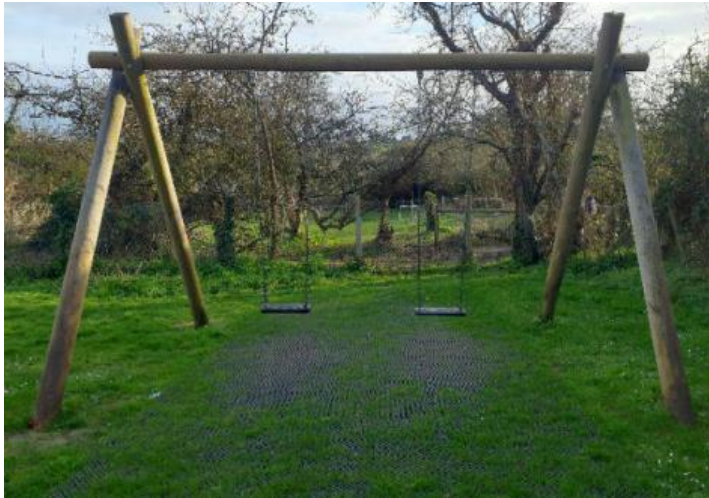
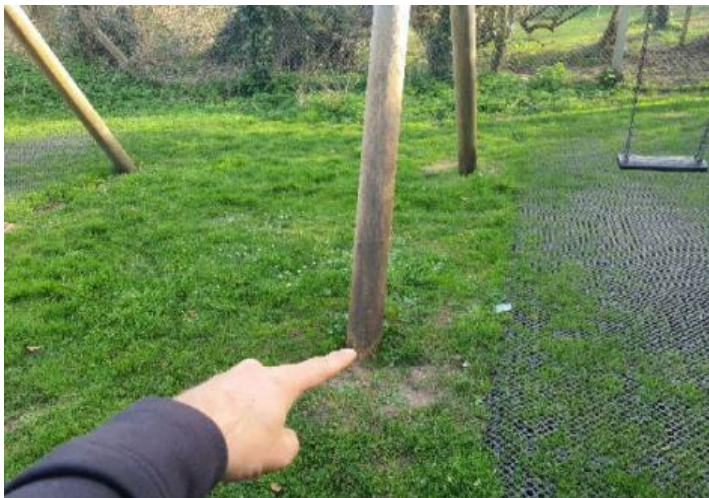
Finding 1
 NOTE: There is a hollow rusty metal pole inside the timber - Refer to manufacturer as to the timber's suitability

Finding: NOTE: There is a hollow rusty metal pole inside the timber

Action: Refer to manufacturer as to the timber's suitability

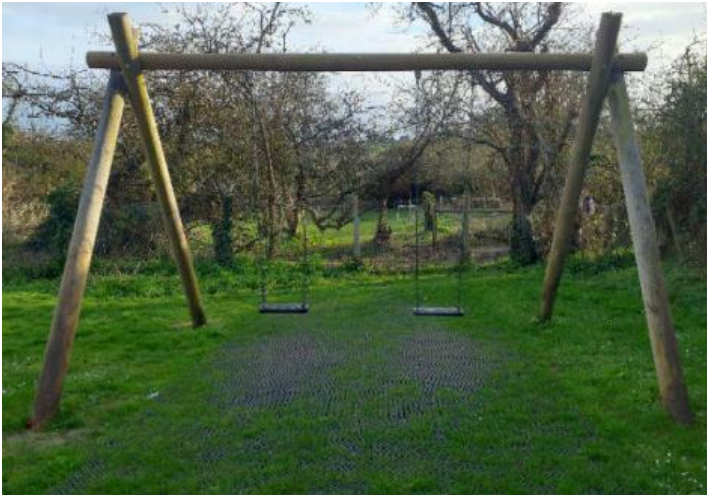
Finding: There is some notable evidence of chain wear

Action: Monitor for any further deterioration and replace when 40% worn

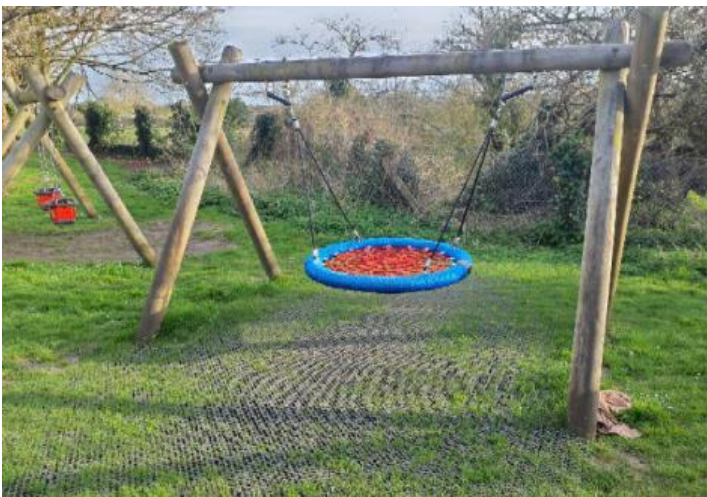
There is some evidence of rot in the timber - Monitor for any further deterioration and replace as required

Finding: There is some evidence of rot in the timber

Action: Monitor for any further deterioration and replace as required

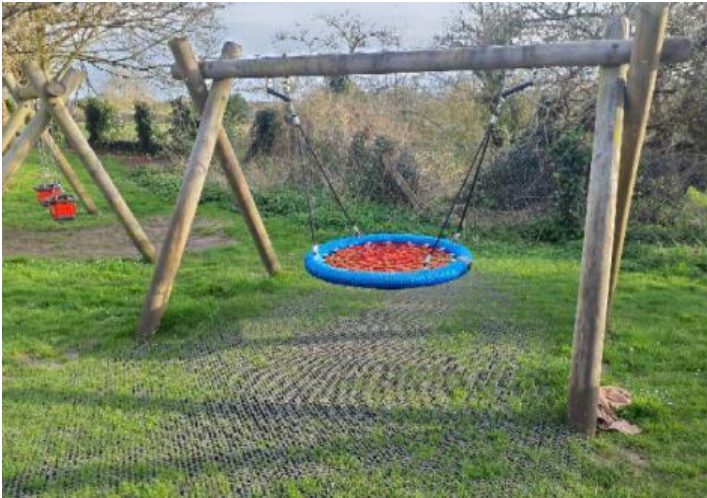
There is/are bolt cap covers missing or damaged on the item - Replace missing or damaged bolt cap covers

Finding: There is/are bolt cap covers missing or damaged on the item

Action: Replace missing or damaged bolt cap covers

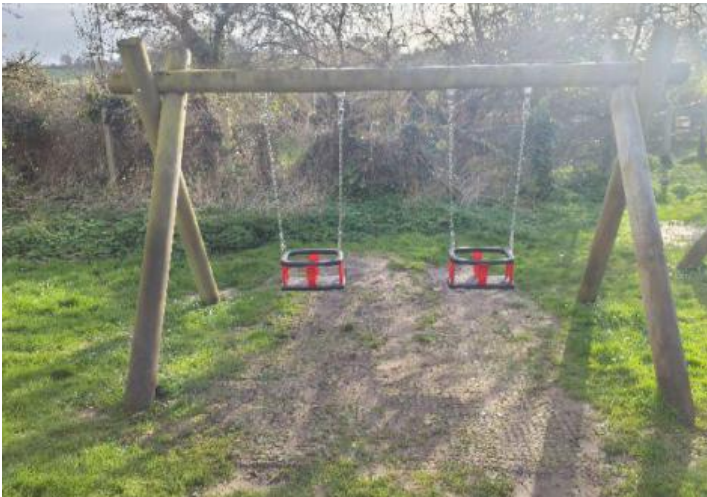
This design of swing joint has been known to fail on the weld connecting the joint to the threaded stud - We would recommend that the joint be dismantled and checked on a regular basis or consulting with manufacturer on whether a Secondary Safety Device can be fitted

Finding: This design of swing joint has been known to fail on the weld connecting the joint to the threaded stud

Action: We would recommend that the joint be dismantled and checked on a regular basis or consulting with manufacturer on whether a Secondary Safety Device can be fitted

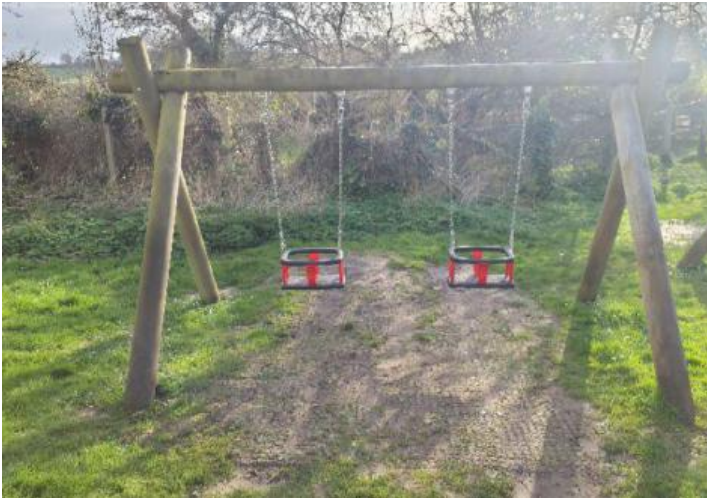
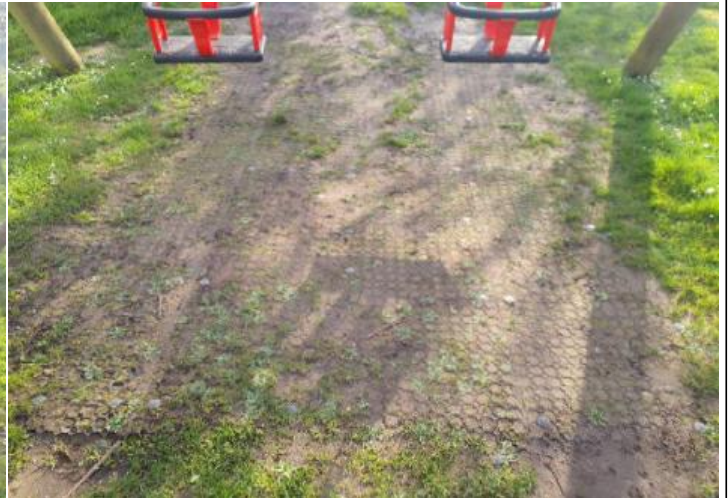
Item: Swings - 1 Bay 2 Seat (Cradle)
Manufacturer: Not Identified

Risk Level: L - Low Risk
Surface: Grass Matrix Tiles

Finding: The grass mats are silted up and the soil is compacted; this may have an effect on the impact absorbing properties of the surface. Consideration should be given to HIC testing the surface to verify impact attenuating properties (<https://playinspections.co.uk/inspection-services/safety-surface-testing/>)

Action: Contact our office for a quotation for this service

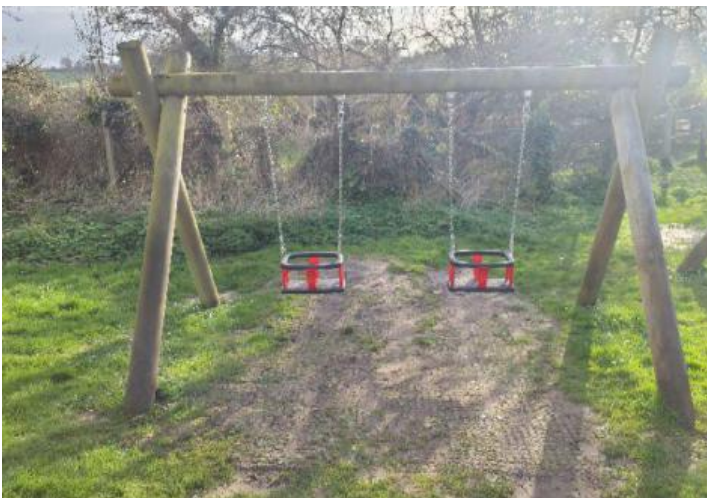
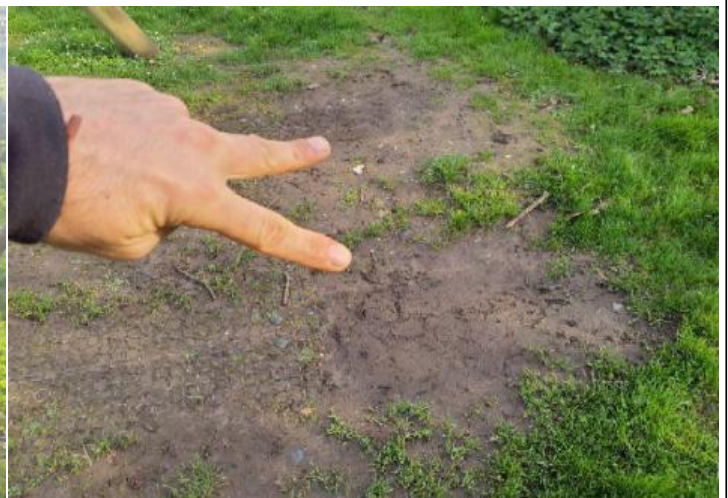
Item: Swings - 1 Bay 2 Seat (Cradle)
Manufacturer: Not Identified

Risk Level: L - Low Risk
Surface: Grass Matrix Tiles

Finding: The area around the item has eroded and may become slippery

Action: Reinststate eroded area

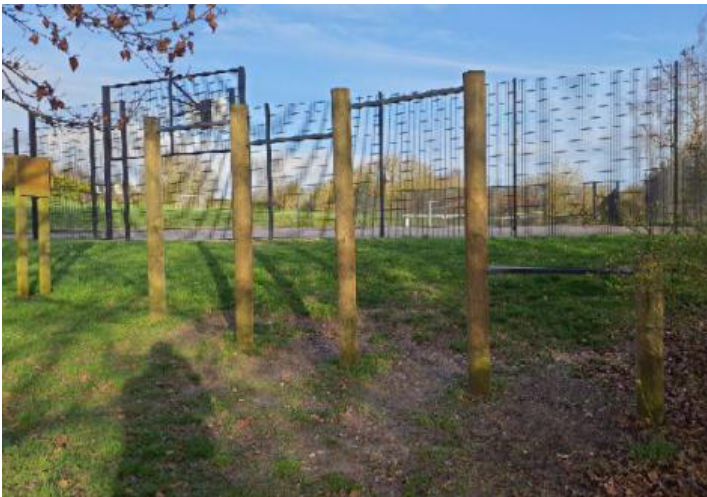
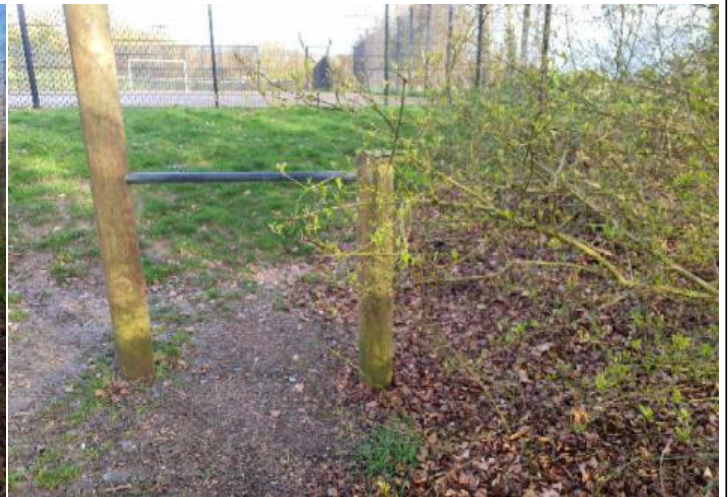
Item: Outdoor Fitness Equipment - Pull Up Station
Manufacturer: Not Identified

Risk Level: L - Low Risk
Surface: Grass Matrix Tiles

Finding: The adjacent foliage is overhanging

Action: Cut back and maintain

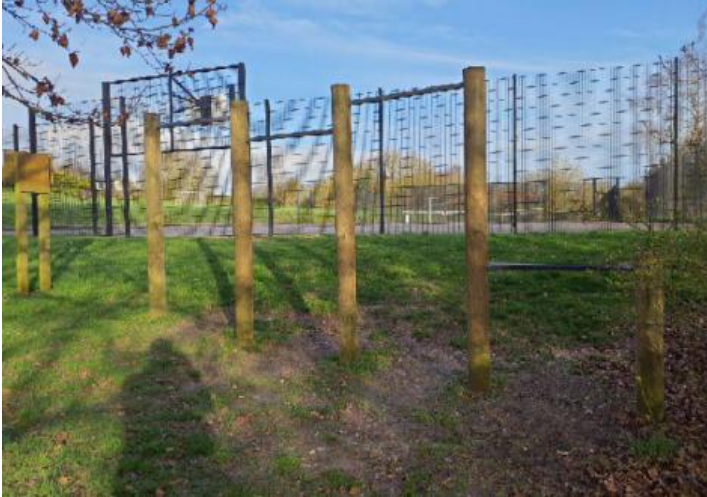
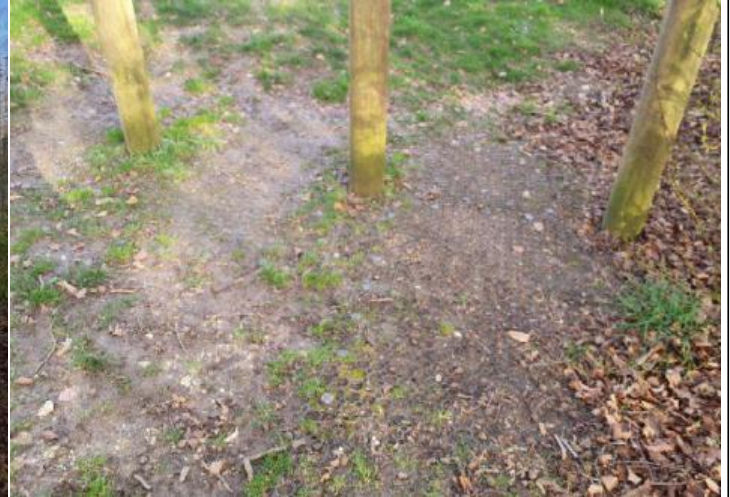
Risk Level: L - Low Risk

Finding: The grass mats are silted up, the soil is compacted and the area will become very slippery when the soil is wet. **Action:** Reinstate as required

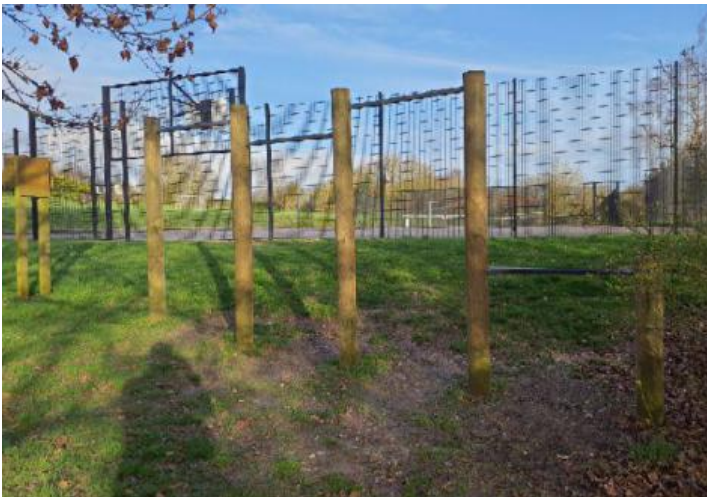
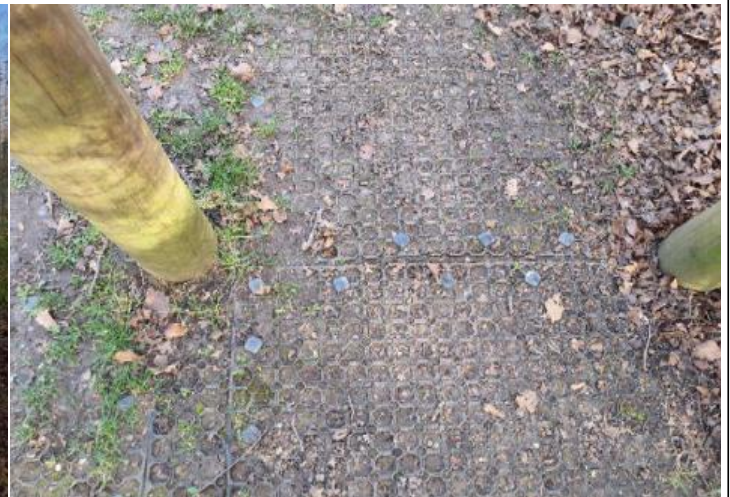
Risk Level: L - Low Risk

Finding: There are gaps opening between the grass mat tiles **Action:** Provide additional ties or secure / reinstate surface tiles

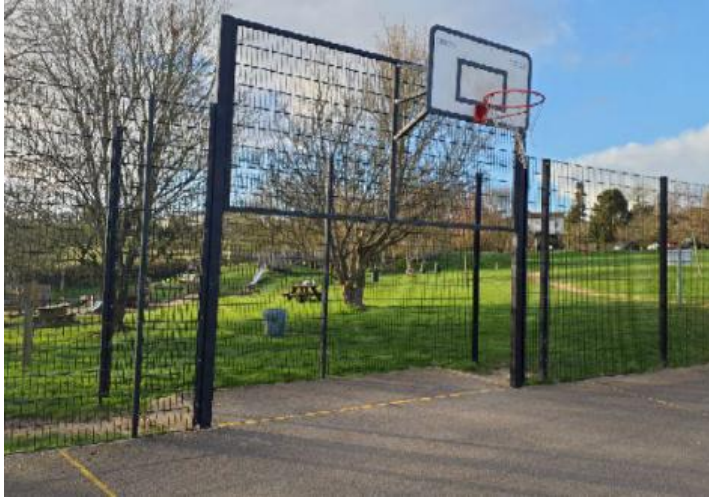
Item: Multi Use Games Area - Multi Use Games Area (MUGA) **Risk Level:** V - Very Low Risk
Manufacturer: Not Identified **Surface:** Bitmac

Finding: A clearly visible facility sign should be provided in a prominent position with the wording as detailed BS EN 15312- the equipment is not intended for children less than 3 years old- the warning - Do not climb on the framework or nets- the warning - Do not hang on the ring (if provided)- the warning - Do not wear rings or other jewellery- name and telephone number of the administrator- number to call in case of accident

Action: Provide signage to BS EN 15312

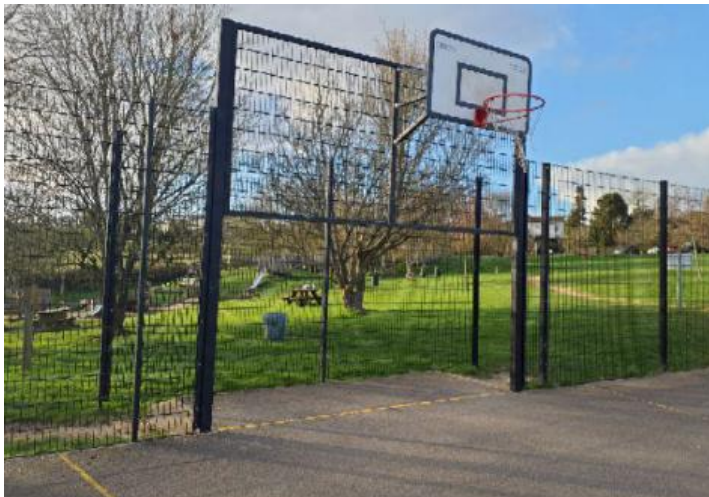
Item:	Multi Use Games Area - Multi Use Games Area (MUGA)	Risk Level:	L - Low Risk
Manufacturer:	Not Identified	Surface:	Bitmac

Finding: The rubber buffer is missing from the latch plate

Action: Replace rubber buffer

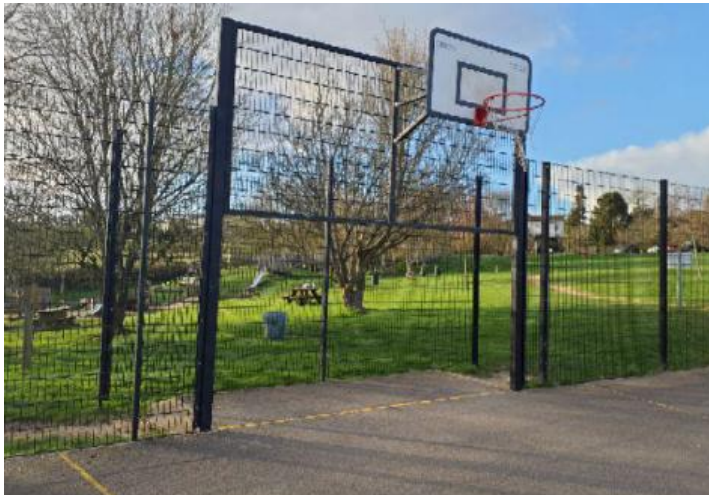
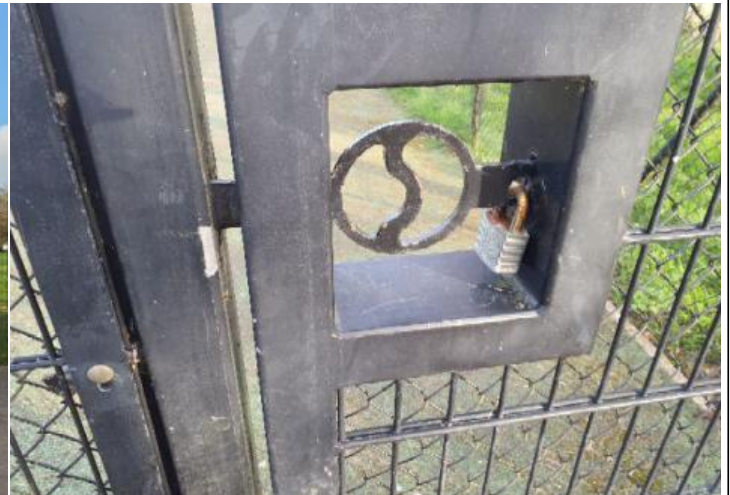
Item: Multi Use Games Area - Multi Use Games Area (MUGA)
Risk Level: N - Risk Assessment not Undertaken
Manufacturer: Not Identified
Surface: Bitmac

Finding: The gate/s was / were locked or secured at the time of the inspection and a full inspection could not be undertaken

Action: Complete inspection of gate/s when re-opened

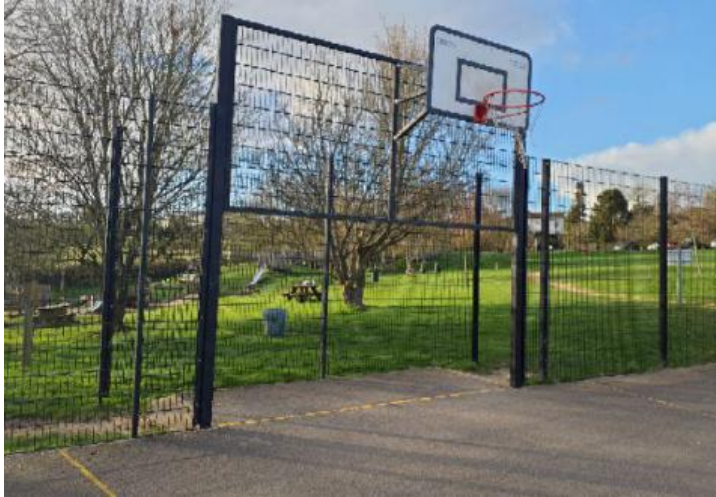
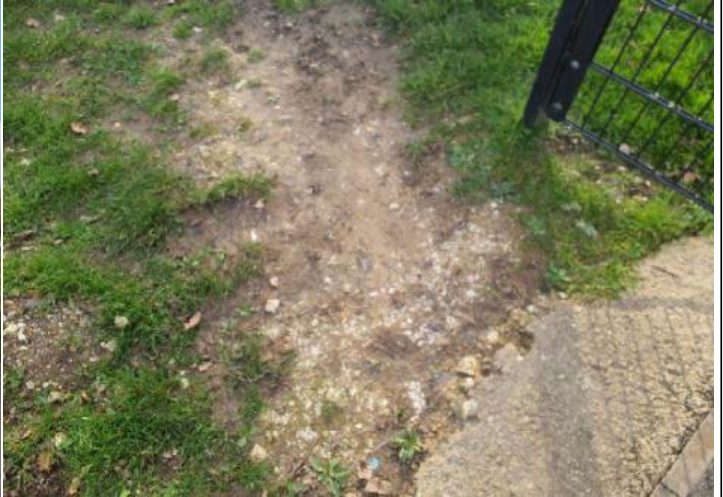
Item:	Multi Use Games Area - Multi Use Games Area (MUGA)	Risk Level:	L - Low Risk
Manufacturer:	Not Identified	Surface:	Bitmac

Finding: The area around the item has eroded and may become slippery

Action: Reinstate eroded area
